## General Information

<b>Make</b>	Toyota	<b>Model</b>	Wigo
<b>YOM</b>	2023	<b>Odo Meter Reading</b>	9,520
<b>Registration No.</b>	GBA6838	<b>Chassis No.</b>	MHKAA1BC4PJ004318
<b>CC</b>	1.0	<b>Transmission</b>	CVT
<b>Fuel Type</b>	Gas	<b>Type of Body</b>	Hatchback
<b>Colour</b>	Gray

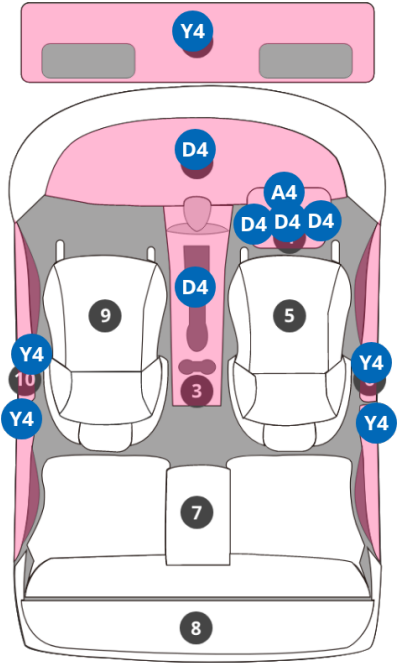
<p><b>a</b> : Cut, Fray <b>d</b> : Loose, Deformed <b>k</b> : Animal Hair <b>s</b> : Smell <b>t</b> : Cigarette Burns <b>x</b> : Defective <b>y</b> : Stain</p>			
<p><b>Remarks</b>            Ceiling - Grime - Large / (R) Front Trim - Grime - Large / (R) Rear Trim - Grime - Large / (L) Rear Trim - Grime - Large / (L) Front Trim - Grime - Large / Console, Switchs, Vents - Loose, Deformed - Large / Dashboard - Loose, Deformed - Large / Steering Wheel - Worn, Peel, Crack - Large / Mat Other - Worked - Large / (R) Front Floor Mat - Worked - Large / (L) Front Floor Mat - Worked - Large</p>	<p><b>Remarks</b>            Defects not found</p>		
<b>Frame Evaluation :</b>	<b>N / A</b>	<b>Functional Evaluation :</b>	<b>N / A</b>
<p><b>Remarks</b>            Defects not found</p>	<p><b>Remarks</b>            Defects not found</p>
