## General Information

<b>Make</b>	Toyota	<b>Model</b>	Avanza
<b>YOM</b>	2025	<b>Odo Meter Reading</b>	622
<b>Registration No.</b>	FAT1633	<b>Chassis No.</b>	MHFAA1BY8S0040327
<b>CC</b>	1.3	<b>Transmission</b>	CVT
<b>Fuel Type</b>	Gas	<b>Type of Body</b>	Wagon
<b>Colour</b>	Silver

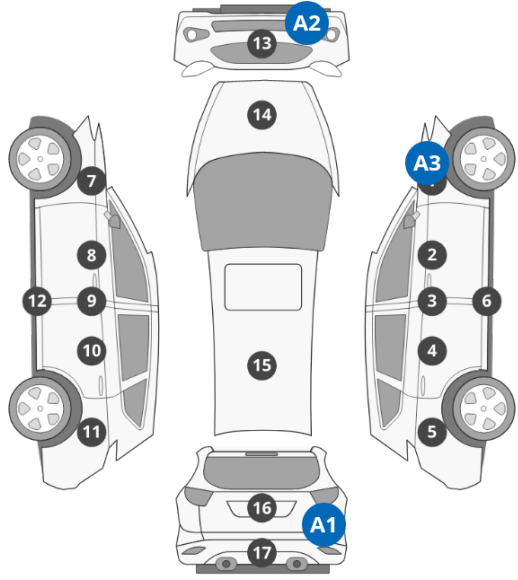
<p><b>A</b> : Scratch <b>AU</b> : Scratch &amp; Dent <b>B</b> : Modified <b>C</b> : Corrosion <b>G</b> : Stone chip <b>P</b> : Faded <b>S</b> : Rust <b>SC</b> : Rust &amp; Corrosion <b>U</b> : Dent <b>X</b> : Defective <b>Y</b> : Crack, Gap</p>
<b>Remarks</b> (R) Front Trim - Cut, Crack - Medium / (L) Front Trim - Cut, Crack - Minimal / (L) Front Floor Mat - Grime - Large / Overall Interior - Smell - Yes	<b>Remarks</b> (R) Front Fender, Molding - Scratch - Medium / Trunk Hood, Rear Gate - Scratch - Minimal / Front Bumper, Grille, Lamps - Scratch - Small
