General Information

Date & Time: 25, Feb, 2026 15:55

Make	Toyota	Model	Avanza
YOM	2024	Odo Meter Reading	62,159
Registration No.	NHM2707	Chassis No.	MHFAA1BYP0022400
CC	1.3	Transmission	CVT
Fuel Type	Gas	Type of Body	MPV
Colour	Red Mica Metallic

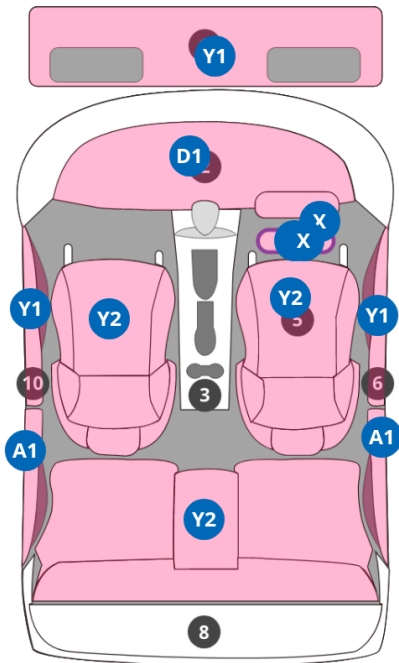
Interior Evaluation : B	Exterior Evaluation : E

<p>a : Cut, Fray d : Loose, Deformed k : Animal Hair s : Smell t : Cigarette Burns x : Defective y : Stain</p>

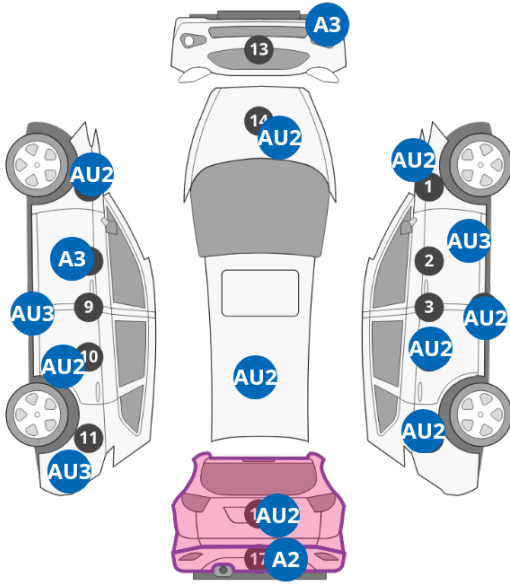
<p>A : Scratch AU : Scratch & Dent B : Modified C : Corrosion G : Stone chip P : Faded S : Rust SC : Rust & Corrosion U : Dent X : Defective Y : Crack, Gap</p>
<p>Remarks (L) Front Seat - Grime - Small / (R) Front Seat - Grime - Small / (R) Front Floor Mat - Missing - Yes / (L) Front Floor Mat - Missing - Yes / Mat Other - Missing - Yes / (L) Rear Trim - Cut, Crack - Minimal / (R) Rear Trim - Cut, Crack - Minimal / (L) Front Trim - Grime - Minimal / (R) Front Trim - Grime - Minimal / Rear Seat - Grime - Small / Ceiling - Grime - Minimal / Dashboard - Worked - Minimal</p>	<p>Remarks (R) Front Fender - Repair Traces - Yes / (L) Front Fender - Repair Traces - Yes / (L) Rear Door - Repair Traces - Yes / Trunk Hood, Rear Gate - Repair Traces - Yes / (L) Rear Fender, Molding - Scratch & Dent - Medium / (L) Rear Door, Molding - Scratch & Dent - Small / (L) Front Door, Molding - Scratch - Medium / (L) Step, In-panel, Side Spoiler - Scratch & Dent - Medium / (L) Front Fender, Molding - Scratch & Dent - Small / Front Bumper, Grille, Lamps - Scratch - Medium / (R) Front Fender, Molding - Scratch & Dent - Small / (R) Front Door, Molding - Scratch & Dent - Medium / (R) Rear Door, Molding - Scratch & Dent - Small / (R) Step, In-panel, Side Spoiler - Scratch & Dent - Small / (R) Rear Fender, Molding - Scratch & Dent - Small / Rear Bumper, Lamps, Panels - Repair mark - Yes / Trunk Hood, Rear Gate - Repair mark - Yes / Trunk Hood, Rear Gate - Scratch & Dent - Small / Rear Bumper, Lamps, Panels - Scratch - Small / Roof - Scratch & Dent - Small / Bonnet, Headlight - Scratch & Dent - Small</p>
