General Information

Date & Time: 26, Feb, 2026 10:45

Make	Toyota	Model	Vios
YOM	2022	Odo Meter Reading	75,053
Registration No.	DAP8329	Chassis No.	PA1B18F30N4171888
CC	1.3	Transmission	CVT
Fuel Type	Gas	Type of Body	Sedan
Colour	Black

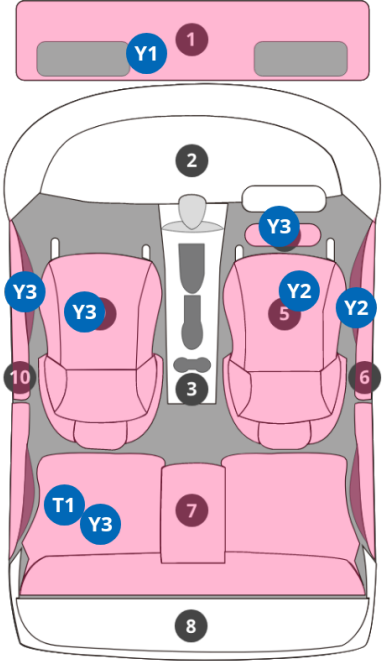
Interior Evaluation : C	Exterior Evaluation : E

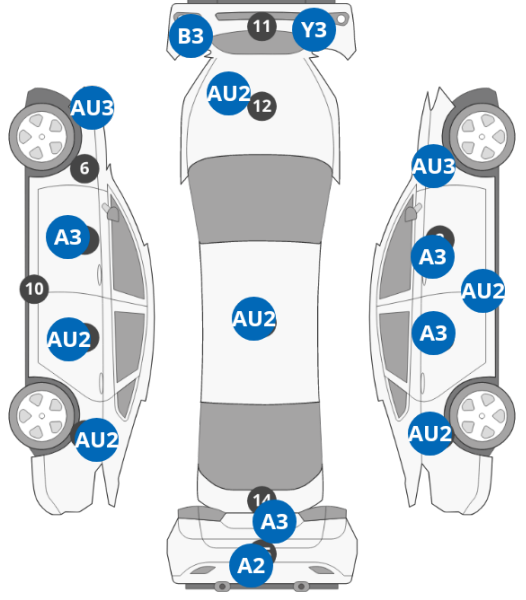
<p>A : Scratch AU : Scratch & Dent B : Modified C : Corrosion G : Stone chip P : Faded S : Rust SC : Rust & Corrosion U : Dent X : Defective Y : Crack, Gap</p>
<p>Remarks (L) Front Trim - Grime - Medium / (L) Front Seat - Grime - Medium / (L) Front Floor Mat - Grime - Medium / (R) Front Seat - Grime - Small / Rear Seat - Grime - Medium / Rear Seat - Cigarette Burns - Burnt Minimal / (R) Front Trim - Grime - Small / Ceiling - Grime - Minimal</p>	<p>Remarks (R) Front Door - Repair Traces - Yes / (R) Front Fender - Repair Traces - Yes / Bonnet - Repair Traces - Yes / (L) Front Fender - Repair Traces - Yes / (L) Front Door - Repair Traces - Yes / (L) Rear Door - Repair Traces - Yes / (L) Rear Fender - Repair Traces - Yes / Trunk Hood, Rear Gate - Repair Traces - Yes / (R) Rear Fender - Repair Traces - Yes / (R) Rear Door - Repair Traces - Yes / Roof - Repair Traces - Yes / Roof - Scratch & Dent - Small / Overall Exterior - Full Re-Paint in same color - Yes / Overall Exterior - Faded(Color, Gloss) - Yes / (L) Rear Fender, Molding - Scratch & Dent - Small / Trunk Hood, Rear Gate - Scratch - Medium / Rear Bumper, Lamps, Panels - Scratch - Small / (L) Rear Door, Molding - Scratch & Dent - Small / (L) Front Door, Molding - Scratch - Medium / (L) Front Fender, Molding - Scratch & Dent - Medium / Bonnet, Headlight - Scratch & Dent - Small / Front Bumper, Grille, Lamps - Crack, Gap - Medium / Front Bumper, Grille, Lamps - Modified - Medium / (R) Front Fender, Molding - Scratch & Dent - Medium / (R) Front Door, Molding - Scratch - Medium / (R) Rear Door, Molding - Scratch - Medium / (R) Step, In-panel, Side Spoiler - Scratch & Dent - Small / (R) Rear Fender, Molding - Scratch & Dent - Small</p>
