General Information

| Make | Toyota | Model | Vios |
| Registration No. | DBQ2859 | Chassis No. | PA1B18F37R4269290 |

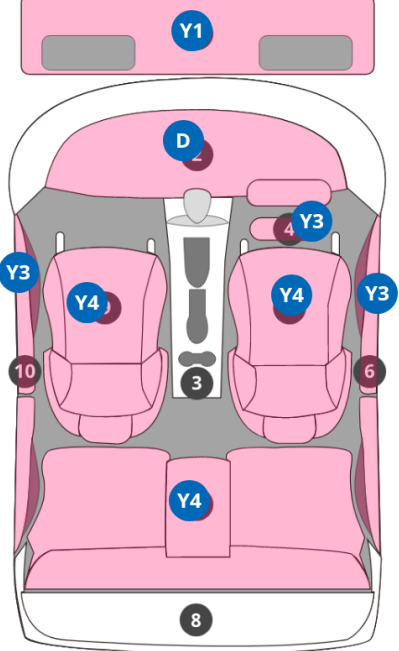
| Interior Evaluation : D | Exterior Evaluation : C |

| <p>Remarks (R) Front Seat - Grime - Large / (R) Front Trim - Grime - Medium / Rear Seat - Grime - Large / (L) Front Trim - Grime - Medium / (L) Front Seat - Grime - Large / (L) Front Floor Mat - Grime - Medium / Ceiling - Grime - Minimal / Dashboard - Traces of Adhesive Tape - Yes</p> | <p>Remarks (L) Front Fender - Repair Traces - Yes / (R) Front Door, Molding - Scratch - Small / (R) Rear Door, Molding - Scratch - Small / (R) Rear Fender, Molding - Scratch - Large / (L) Front Fender, Molding - Repair mark - Yes / Trunk Hood, Rear Gate - Scratch & Dent - Small / Rear Bumper, Lamps, Panels - Scratch - Small / (L) Rear Fender, Molding - Scratch - Minimal / (L) Rear Door, Molding - Scratch - Minimal / (L) Front Door, Molding - Scratch - Small / (L) Front Fender, Molding - Scratch - Small / Front Bumper, Grille, Lamps - Scratch - Medium / Bonnet, Headlight - Scratch - Small / Roof - Scratch - Small</p> |
