## General Information

<b>Make</b>	Toyota	<b>Model</b>	Avanza
<b>YOM</b>	2025	<b>Odo Meter Reading</b>	9,959
<b>Registration No.</b>	EAL1323	<b>Chassis No.</b>	MHFAA1BY0S0039804
<b>CC</b>	1.3	<b>Transmission</b>	CVT
<b>Fuel Type</b>	Gas	<b>Type of Body</b>	Wagon
<b>Colour</b>	Red Mica Metallic

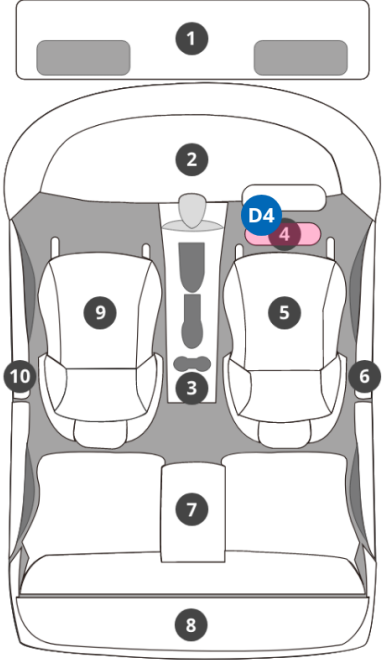
<b>Interior Evaluation :</b> <span style="color: red; font-weight: bold; font-size: 1.2em;">C</span>	<b>Exterior Evaluation :</b> <span style="color: red; font-weight: bold; font-size: 1.2em;">E</span>

<p><b>A</b> : Scratch <b>AU</b> : Scratch &amp; Dent <b>B</b> : Modified <b>C</b> : Corrosion <b>G</b> : Stone chip <b>P</b> : Faded <b>S</b> : Rust <b>SC</b> : Rust &amp; Corrosion <b>U</b> : Dent <b>X</b> : Defective <b>Y</b> : Crack, Gap</p>
<p><b>Remarks</b> (L) Front Floor Mat - Worked - Large</p>	<p><b>Remarks</b> (R) Front Door, Molding - Scratch &amp; Dent - Large / (R) Rear Door, Molding - Scratch &amp; Dent - Large / (R) Rear Fender, Molding - Scratch - Small / Rear Bumper, Lamps, Panels - Scratch &amp; Dent - Large / (L) Rear Door, Molding - Scratch - Large / (L) Front Fender, Molding - Scratch - Large / Front Bumper, Grille, Lamps - Scratch &amp; Dent - Large / Roof - Scratch &amp; Dent - Large / (R) Front Fender, Molding - Scratch - Medium / Trunk Hood, Rear Gate - Scratch - Minimal / (L) Front Door, Molding - Scratch - Small / (R) Step, In-panel, Side Spoiler - Scratch &amp; Dent - Medium</p>
