General Information

Make	Toyota	Model	Innova
YOM	2025	Odo Meter Reading	29,728
Registration No.	CCF6316	Chassis No.	PA2JA8EMXR0147029
CC	2.8	Transmission	A/T
Fuel Type	Diesel	Type of Body	Wagon
Colour	Black

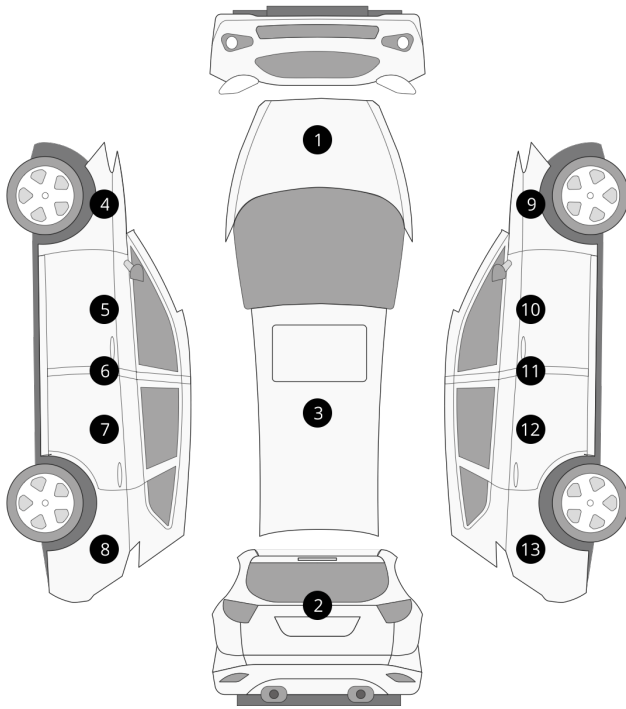
Body / Panel Condition

#	Area	Thickness(um)			
		Average	Value1	Value2	Value3/4
1	Bonnet	110.3	103	115	113
2	Boot Lid	109.6	108	108	113
3	Roof	101.9	94	100	112/102
4	Left Front Fender	105.5	108	109	100
5	Left Front Door	156.0	144	169	155
6	Center Panel Left				
7	Left Rear Door	107.3	104	107	111
8	Left Back Panel	118.6	130	111	115
9	Right Front Fender	195.3	226	197	163
10	Right Front Door	100.4	99	100	102
11	Center Panel Right				
12	Right Rear Door	105.0	99	104	112
13	Right Back Panel	109.3	111	106	111

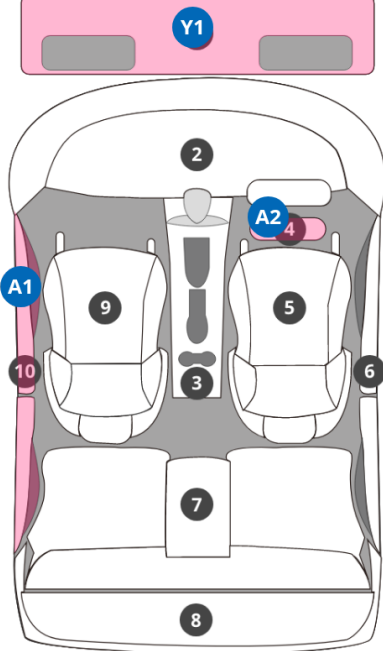
Interior Evaluation : A	Exterior Evaluation : C

<p>A : Scratch AU : Scratch & Dent B : Modified C : Corrosion G : Stone chip P : Faded S : Rust SC : Rust & Corrosion U : Dent X : Defective Y : Crack, Gap</p>
<p>Remarks Ceiling - Grime - Minimal / (L) Front Trim - Cut, Crack - Minimal / (L) Front Floor Mat - Cut, Crack - Small</p>	<p>Remarks (R) Front Fender - Repair Traces - Yes / (R) Front Fender, Molding - Repair mark - Yes / (R) Front Fender, Molding - Scratch - Minimal / (R) Mirror - Scratch - Minimal / (R) Front Door, Molding - Scratch - Minimal / (R) Rear Door, Molding - Scratch - Minimal / (R) Step, In-panel, Side Spoiler - Scratch - Minimal / (R) Rear Fender, Molding - Scratch - Minimal / Roof - Scratch - Minimal / Rear Bumper, Lamps, Panels - Scratch - Small / (L) Rear Fender, Molding - Scratch & Dent - Medium / (L) Rear Door, Molding - Scratch - Minimal / (L) Front Door, Molding - Scratch - Small / (L) Front Fender, Molding - Scratch - Minimal / Front Bumper, Grille, Lamps - Scratch & Dent - Medium / Trunk Hood, Rear Gate - Scratch & Dent - Minimal</p>
