## General Information

<b>Make</b>	Toyota	<b>Model</b>	Veloz
<b>YOM</b>	2023	<b>Odo Meter Reading</b>	20,971
<b>Registration No.</b>	DBI6913	<b>Chassis No.</b>	MHFAB1BYXN3039566
<b>CC</b>	1.5	<b>Transmission</b>	CVT
<b>Fuel Type</b>	Gas	<b>Type of Body</b>	SUV
<b>Colour</b>	Silver

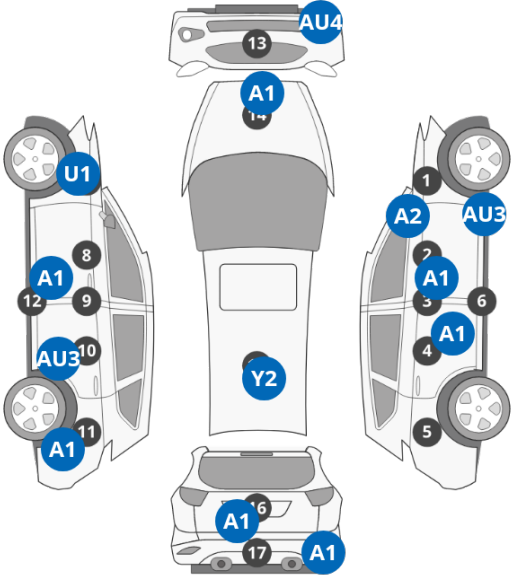
<p><b>A</b> : Scratch <b>AU</b> : Scratch &amp; Dent <b>B</b> : Modified <b>C</b> : Corrosion <b>G</b> : Stone chip <b>P</b> : Faded <b>S</b> : Rust <b>SC</b> : Rust &amp; Corrosion <b>U</b> : Dent <b>X</b> : Defective <b>Y</b> : Crack, Gap</p>
<b>Remarks</b> (L) Front Floor Mat - Grime - Minimal	<b>Remarks</b> (R) Mirror - Scratch - Small / (R) Front Door, Molding - Scratch - Minimal / (R) Step, In-panel, Side Spoiler - Scratch & Dent - Medium / (R) Rear Door, Molding - Scratch - Minimal / Trunk Hood, Rear Gate - Scratch - Minimal / Rear Bumper, Lamps, Panels - Scratch - Minimal / Roof Spoiler, Molding - Crack, Gap - Small / (L) Rear Fender, Molding - Scratch - Minimal / (L) Rear Door, Molding - Scratch & Dent - Medium / (L) Front Door, Molding - Scratch - Minimal / (L) Front Fender, Molding - Dent - Minimal / Front Bumper, Grille, Lamps - Scratch & Dent - Large / Bonnet, Headlight - Scratch - Minimal
