## General Information

<b>Make</b>	Toyota	<b>Model</b>	Vios
<b>YOM</b>	2023	<b>Odo Meter Reading</b>	134,855
<b>Registration No.</b>	NIK2608	<b>Chassis No.</b>	PA1B18F321P4215481
<b>CC</b>	1.3	<b>Transmission</b>	CVT
<b>Fuel Type</b>	Gas	<b>Type of Body</b>	Sedan
<b>Colour</b>	Red Mica Metallic

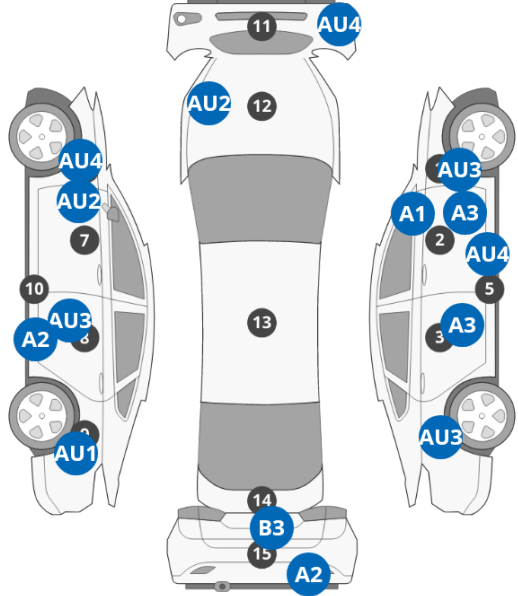
<p><b>A</b> : Scratch <b>AU</b> : Scratch &amp; Dent <b>B</b> : Modified <b>C</b> : Corrosion <b>G</b> : Stone chip <b>P</b> : Faded <b>S</b> : Rust <b>SC</b> : Rust &amp; Corrosion <b>U</b> : Dent <b>X</b> : Defective <b>Y</b> : Crack, Gap</p>
<p><b>Remarks</b> Sunvisor, Sunglass Holder - Grime - Small / (R) Front Trim - Grime - Minimal / (R) Front Floor Mat - Missing - Yes / (L) Front Floor Mat - Grime - Minimal / (L) Front Trim - Grime - Minimal</p>	<p><b>Remarks</b> (R) Front Fender - Repair Traces - Yes / (R) Front Fender, Molding - Scratch &amp; Dent - Medium / (R) Mirror - Scratch - Minimal / (R) Front Door, Molding - Scratch - Medium / (R) Step, In-panel, Side Spoiler - Scratch &amp; Dent - Large / (R) Rear Door, Molding - Scratch - Medium / (R) Rear Fender, Molding - Scratch &amp; Dent - Medium / Trunk Hood, Rear Gate - Modified - Medium / Rear Bumper, Lamps, Panels - Scratch - Small / (L) Rear Fender, Molding - Scratch &amp; Dent - Minimal / (L) Rear Door, Molding - Scratch &amp; Dent - Medium / (L) Step, In-panel, Side Spoiler - Scratch - Small / (L) Front Door, Molding - Scratch &amp; Dent - Small / (L) Front Fender, Molding - Scratch &amp; Dent - Large / Front Bumper, Grille, Lamps - Scratch &amp; Dent - Large / Bonnet, Headlight - Scratch &amp; Dent - Small</p>
