## General Information

Date & Time: 26, Feb, 2026 15:14

<b>Make</b>	Toyota	<b>Model</b>	Vios
<b>YOM</b>	2023	<b>Odo Meter Reading</b>	91,423
<b>Registration No.</b>	CBT5958	<b>Chassis No.</b>	PA1B18F30P4203550
<b>CC</b>	1.3	<b>Transmission</b>	CVT
<b>Fuel Type</b>	Gas	<b>Type of Body</b>	Sedan
<b>Colour</b>	Silver

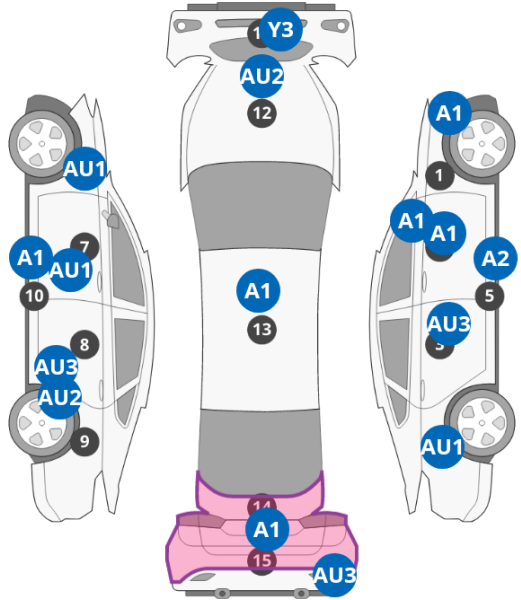
<p><b>A</b> : Scratch <b>AU</b> : Scratch &amp; Dent <b>B</b> : Modified <b>C</b> : Corrosion <b>G</b> : Stone chip <b>P</b> : Faded <b>S</b> : Rust <b>SC</b> : Rust &amp; Corrosion <b>U</b> : Dent <b>X</b> : Defective <b>Y</b> : Crack, Gap</p>
<p><b>Remarks</b> (L) Front Trim - Grime - Minimal / (R) Front Trim - Grime - Minimal</p>	<p><b>Remarks</b> Trunk Hood, Rear Gate - Repair Traces - Yes / (R) Front Fender, Molding - Scratch - Minimal / (R) Mirror - Scratch - Minimal / (R) Front Door, Molding - Scratch - Minimal / (R) Step, In-panel, Side Spoiler - Scratch - Small / (R) Rear Door, Molding - Scratch &amp; Dent - Medium / (R) Rear Fender, Molding - Scratch &amp; Dent - Minimal / Rear Bumper, Lamps, Panels - Scratch &amp; Dent - Medium / Trunk Hood, Rear Gate - Repair mark - Yes / Trunk Hood, Rear Gate - Scratch - Minimal / (L) Rear Fender, Molding - Scratch &amp; Dent - Small / (L) Rear Door, Molding - Scratch &amp; Dent - Medium / (L) Front Door, Molding - Scratch &amp; Dent - Minimal / Roof - Scratch - Minimal / (L) Front Fender, Molding - Scratch &amp; Dent - Minimal / Front Bumper, Grille, Lamps - Crack, Gap - Medium / Bonnet, Headlight - Scratch &amp; Dent - Small / (L) Step, In-panel, Side Spoiler - Scratch - Minimal</p>
