## General Information

| <b>Make</b> | Toyota | <b>Model</b> | Wigo |
| <b>Registration No.</b> | DBN8418 | <b>Chassis No.</b> | MHKAA1BC5PJ009513 |

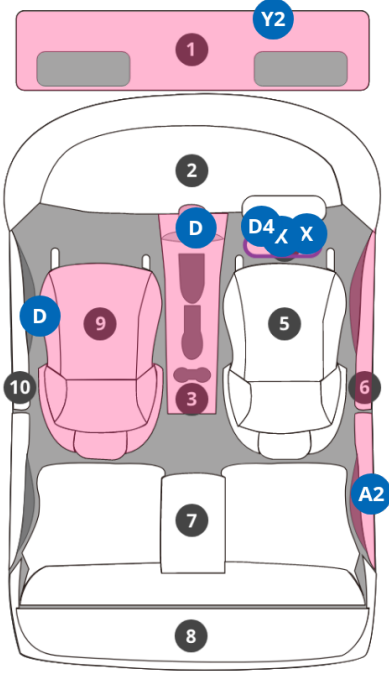
| <b>Interior Evaluation :</b> <span style="float: right; color: red; font-weight: bold;">C</span> | <b>Exterior Evaluation :</b> <span style="float: right; color: red; font-weight: bold;">E</span> |

| <p><b>Remarks</b><br/>(R) Rear Trim - Cut, Crack - Small / (L) Front Seat - Worn - Yes / (R) Front Floor Mat - Missing - Yes / (L) Front Floor Mat - Missing - Yes / Ceiling - Grime - Small / Console, Switches, Vents - Traces of Adhesive Tape - Yes / Carpet - Worked - Large</p> | <p><b>Remarks</b><br/>(R) Front Fender, Molding - Scratch - Medium / (R) Mirror - Crack - Cracks / (R) Front Door, Molding - Scratch - Minimal / (R) Rear Door, Molding - Scratch &amp; Dent - Large / (R) Rear Fender, Molding - Scratch - Medium / (R) Step, In-panel, Side Spoiler - Crack, Gap - Small / Rear Bumper, Lamps, Panels - Scratch - Large / Trunk Hood, Rear Gate - Scratch - Small / (L) Rear Fender, Molding - Scratch &amp; Dent - Large / (L) Rear Door, Molding - Scratch - Small / (L) Step, In-panel, Side Spoiler - Scratch - Minimal / (L) Front Door, Molding - Scratch - Medium / (L) Front Fender, Molding - Scratch - Medium / Front Bumper, Grille, Lamps - Scratch &amp; Dent - Large / Bonnet, Headlight - Scratch - Minimal / Roof - Scratch - Minimal</p> |
