## General Information

<b>Make</b>	Toyota	<b>Model</b>	Vios
<b>YOM</b>	2022	<b>Odo Meter Reading</b>	92,796
<b>Registration No.</b>	NIC9921	<b>Chassis No.</b>	PA1B18F36N4183253
<b>CC</b>	1.3	<b>Transmission</b>	CVT
<b>Fuel Type</b>	Gas	<b>Type of Body</b>	Sedan
<b>Colour</b>	Red Mica Metallic

## Body / Panel Condition

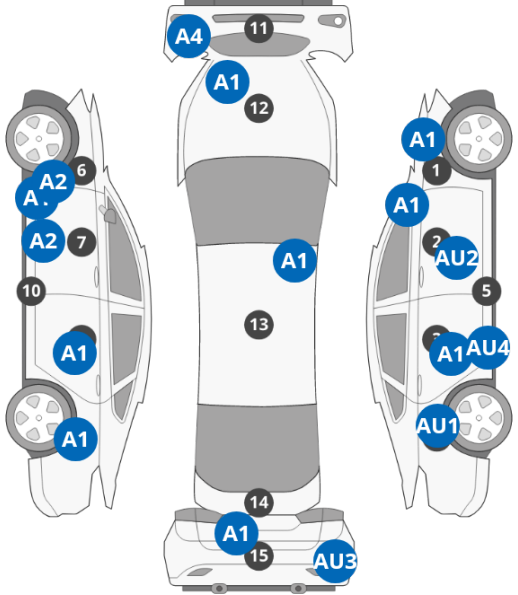
<p><b>A</b> : Scratch <b>AU</b> : Scratch &amp; Dent <b>B</b> : Modified <b>C</b> : Corrosion <b>G</b> : Stone chip <b>P</b> : Faded <b>S</b> : Rust <b>SC</b> : Rust &amp; Corrosion <b>U</b> : Dent <b>X</b> : Defective <b>Y</b> : Crack, Gap</p>
<p><b>Remarks</b> (R) Front Floor Mat - Missing - Yes / Mat Other - Missing - Yes / (L) Front Trim - Grime - Minimal / (R) Front Seat - Grime - Minimal / Rear Seat - Grime - Minimal / Ceiling - Grime - Minimal</p>	<p><b>Remarks</b> (R) Front Fender, Molding - Scratch - Minimal / (R) Mirror - Scratch - Minimal / (R) Front Door, Molding - Scratch &amp; Dent - Small / (R) Rear Door, Molding - Scratch - Minimal / (R) Step, In-panel, Side Spoiler - Scratch &amp; Dent - Large / (R) Rear Fender, Molding - Scratch &amp; Dent - Minimal / Trunk Hood, Rear Gate - Scratch - Minimal / (L) Rear Fender, Molding - Scratch - Minimal / (L) Rear Door, Molding - Scratch - Minimal / (L) Front Door, Molding - Scratch - Small / (L) Step, In-panel, Side Spoiler - Scratch - Minimal / (L) Front Fender, Molding - Scratch - Small / Roof - Scratch - Minimal / Bonnet, Headlight - Scratch - Minimal / Front Bumper, Grille, Lamps - Scratch - Large / Rear Bumper, Lamps, Panels - Scratch &amp; Dent - Medium</p>

<p><b>Inspector Notes</b></p>
<p>With Lto plate, with warranty booklet, with spare tire, no jack and tools, scratches on headlights and taillights</p>
