## General Information

<b>Make</b>	Toyota	<b>Model</b>	Vios
<b>YOM</b>	2024	<b>Odo Meter Reading</b>	39,710
<b>Registration No.</b>	KAT1268	<b>Chassis No.</b>	PA1B18F30P4231946
<b>CC</b>	1.3	<b>Transmission</b>	CVT
<b>Fuel Type</b>	Gas	<b>Type of Body</b>	Sedan
<b>Colour</b>	Red Mica Metallic

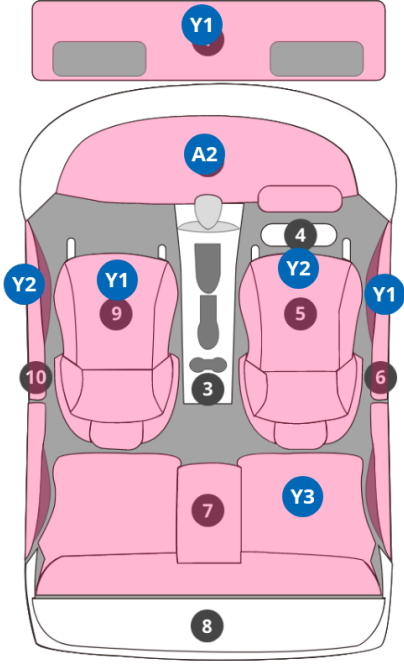
<b>Interior Evaluation :</b> <span style="float: right; color: red; font-weight: bold;">B</span>	<b>Exterior Evaluation :</b> <span style="float: right; color: red; font-weight: bold;">C</span>

<p><b>a</b> : Cut, Fray <b>d</b> : Loose, Deformed <b>k</b> : Animal Hair <b>s</b> : Smell <b>t</b> : Cigarette Burns <b>x</b> : Defective <b>y</b> : Stain</p>

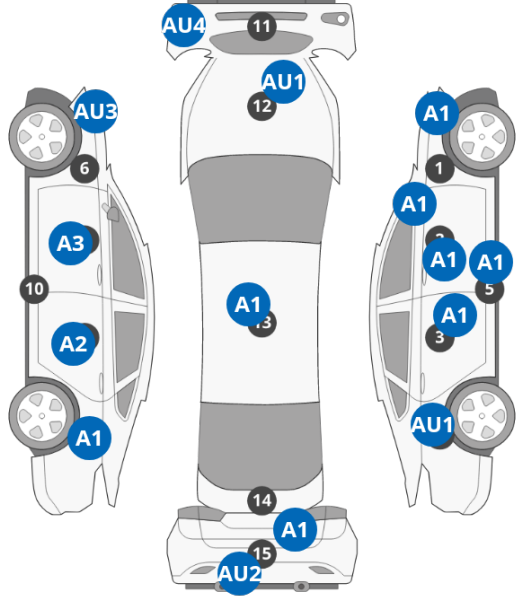
<p><b>A</b> : Scratch <b>AU</b> : Scratch &amp; Dent <b>B</b> : Modified <b>C</b> : Corrosion <b>G</b> : Stone chip <b>P</b> : Faded <b>S</b> : Rust <b>SC</b> : Rust &amp; Corrosion <b>U</b> : Dent <b>X</b> : Defective <b>Y</b> : Crack, Gap</p>
<p><b>Remarks</b> Ceiling - Grime - Minimal / (L) Front Seat - Grime - Minimal / (R) Front Seat - Grime - Small / (R) Front Trim - Grime - Minimal / Rear Seat - Grime - Medium / (L) Front Trim - Grime - Small / Dashboard - Worn, Scratch, Cut, Crack - Small</p>	<p><b>Remarks</b> (R) Front Fender, Molding - Scratch - Minimal / (R) Mirror - Scratch - Minimal / (R) Front Door, Molding - Scratch - Minimal / (R) Step, In-panel, Side Spoiler - Scratch - Minimal / (R) Rear Door, Molding - Scratch - Minimal / (R) Rear Fender, Molding - Scratch &amp; Dent - Minimal / Rear Bumper, Lamps, Panels - Scratch &amp; Dent - Small / Trunk Hood, Rear Gate - Scratch - Minimal / (L) Rear Fender, Molding - Scratch - Minimal / (L) Rear Door, Molding - Scratch - Small / (L) Front Door, Molding - Scratch - Medium / Roof - Scratch - Minimal / (L) Front Fender, Molding - Scratch &amp; Dent - Medium / Front Bumper, Grille, Lamps - Scratch &amp; Dent - Large / Bonnet, Headlight - Scratch &amp; Dent - Minimal</p>
