General Information

Date & Time: 26, Feb, 2026 12:12

Make	Toyota	Model	Hiace
YOM	2024	Odo Meter Reading	49,692
Registration No.	NIS4283	Chassis No.	JTNAFAP58035704
CC	2.8	Transmission	M/T
Fuel Type	Diesel	Type of Body	Van
Colour	Silver

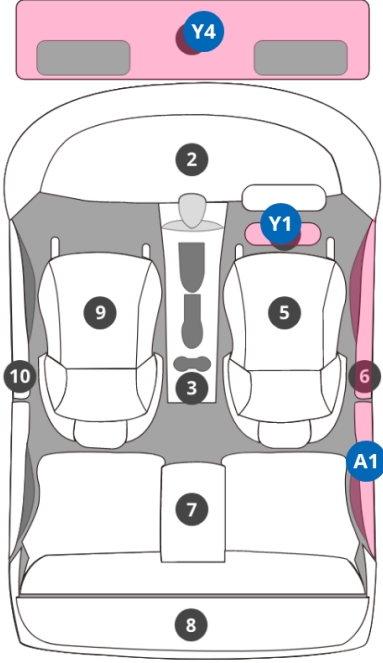
Interior Evaluation : C	Exterior Evaluation : C

<p>a : Cut, Fray d : Loose, Deformed k : Animal Hair s : Smell t : Cigarette Burns x : Defective y : Stain</p>

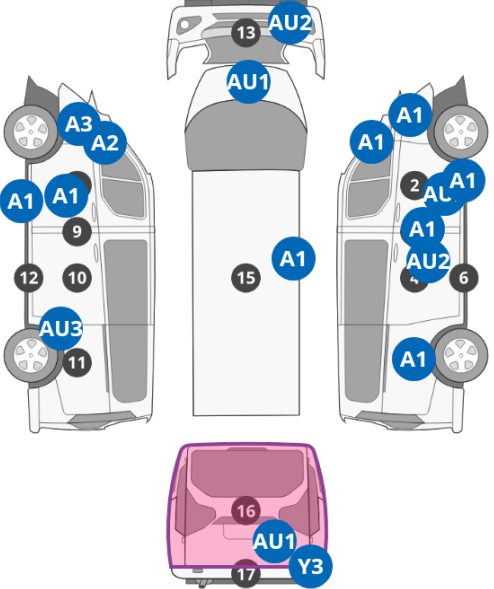
<p>A : Scratch AU : Scratch & Dent B : Modified C : Corrosion G : Stone chip P : Faded S : Rust SC : Rust & Corrosion U : Dent X : Defective Y : Crack, Gap</p>
<p>Remarks Trim Other - Cut, Crack - Minimal / (R) Front Floor Mat - Grime - Minimal / Ceiling - Grime - Large</p>	<p>Remarks Trunk Hood, Rear Gate - Repair Traces - Yes / (R) Front Fender, Molding - Scratch - Minimal / (R) Mirror - Scratch - Minimal / (R) Front Door, Molding - Scratch & Dent - Small / (R) Step, In-panel, Side Spoiler - Scratch - Minimal / (R) Center Panel - Scratch - Minimal / (R) Rear Door, Molding - Scratch & Dent - Small / (R) Rear Fender, Molding - Scratch - Minimal / Roof - Scratch - Minimal / Trunk Hood, Rear Gate - Repair mark - Yes / Trunk Hood, Rear Gate - Scratch & Dent - Minimal / (L) Rear Fender, Molding - Scratch & Dent - Medium / (L) Mirror - Scratch - Small / (L) Front Door, Molding - Scratch - Minimal / (L) Front Fender, Molding - Scratch - Medium / Bonnet, Headlight - Scratch & Dent - Minimal / Front Bumper, Grille, Lamps - Scratch & Dent - Small / (L) Step, In-panel, Side Spoiler - Scratch - Minimal / Rear Bumper, Lamps, Panels - Crack, Gap - Medium</p>
