## General Information

<b>Make</b>	Toyota	<b>Model</b>	Vios
<b>YOM</b>	2025	<b>Odo Meter Reading</b>	46,567
<b>Registration No.</b>	NHS8987	<b>Chassis No.</b>	PA1B18F37R4270357
<b>CC</b>	1.3	<b>Transmission</b>	CVT
<b>Fuel Type</b>	Gas	<b>Type of Body</b>	Sedan
<b>Colour</b>	Black

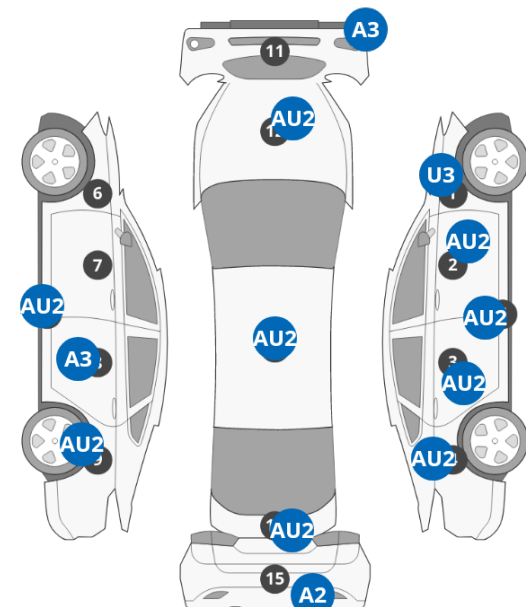
<p><b>A</b> : Scratch <b>AU</b> : Scratch &amp; Dent <b>B</b> : Modified <b>C</b> : Corrosion <b>G</b> : Stone chip <b>P</b> : Faded <b>S</b> : Rust <b>SC</b> : Rust &amp; Corrosion <b>U</b> : Dent <b>X</b> : Defective <b>Y</b> : Crack, Gap</p>
<p><b>Remarks</b>  (L) Front Floor Mat - Cut, Crack - Medium / (L) Front Seat - Grime - Small / (R) Front Seat - Grime - Small / (L) Front Trim - Grime - Small / (R) Front Trim - Grime - Small / Rear Seat - Grime - Small / Ceiling - Grime - Small / Mat Other - Grime - Small</p>	<p><b>Remarks</b>  (L) Front Door - Repair Traces - Yes / Roof - Scratch &amp; Dent - Small / (L) Rear Door, Molding - Scratch - Medium / (L) Step, In-panel, Side Spoiler - Scratch &amp; Dent - Small / (L) Rear Fender, Molding - Scratch &amp; Dent - Small / Trunk Hood, Rear Gate - Scratch &amp; Dent - Small / Rear Bumper, Lamps, Panels - Scratch - Small / (R) Rear Fender, Molding - Scratch &amp; Dent - Small / (R) Rear Door, Molding - Scratch &amp; Dent - Small / (R) Front Door, Molding - Scratch &amp; Dent - Small / (R) Front Fender, Molding - Dent - Medium / Bonnet, Headlight - Scratch &amp; Dent - Small / Front Bumper, Grille, Lamps - Scratch - Medium</p>
