## General Information

<b>Make</b>	Toyota	<b>Model</b>	Wigo
<b>YOM</b>	2023	<b>Odo Meter Reading</b>	18,468
<b>Registration No.</b>	NFC8388	<b>Chassis No.</b>	MHKAA1BCOPJ001593
<b>CC</b>	1.0	<b>Transmission</b>	CVT
<b>Fuel Type</b>	Gas	<b>Type of Body</b>	Hatchback
<b>Colour</b>	Yellow

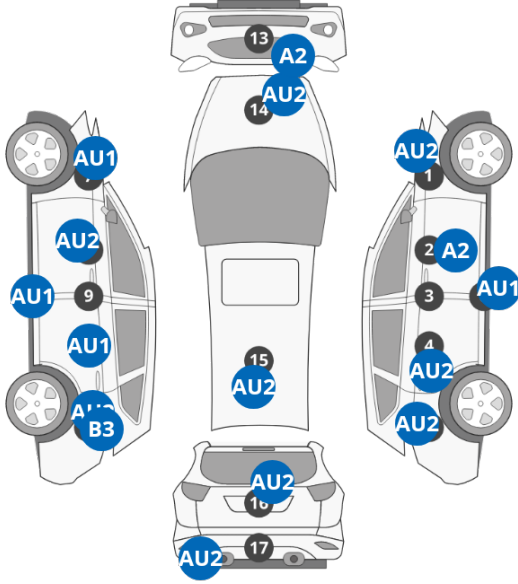
<p><b>A</b> : Scratch <b>AU</b> : Scratch &amp; Dent <b>B</b> : Modified <b>C</b> : Corrosion <b>G</b> : Stone chip <b>P</b> : Faded <b>S</b> : Rust <b>SC</b> : Rust &amp; Corrosion <b>U</b> : Dent <b>X</b> : Defective <b>Y</b> : Crack, Gap</p>
<p><b>Remarks</b> (L) Front Seat - Grime - Medium / Rear Seat - Grime - Medium / (R) Front Seat - Grime - Medium / (R) Front Trim - Grime - Minimal / (L) Front Trim - Grime - Minimal / Ceiling - Grime - Small / Glove Box - Worked - Minimal / (L) Front Floor Mat - Grime - Minimal / (R) Front Floor Mat - Grime - Minimal</p>	<p><b>Remarks</b> Roof - Scratch &amp; Dent - Small / (L) Rear Door, Molding - Scratch &amp; Dent - Minimal / (L) Rear Fender, Molding - Scratch &amp; Dent - Small / (L) Rear Fender, Molding - Modified - Medium / Trunk Hood, Rear Gate - Scratch &amp; Dent - Small / Rear Bumper, Lamps, Panels - Scratch &amp; Dent - Small / (R) Rear Fender, Molding - Scratch &amp; Dent - Small / (R) Rear Door, Molding - Scratch &amp; Dent - Small / (R) Front Door, Molding - Scratch - Small / (R) Front Fender, Molding - Scratch &amp; Dent - Small / Bonnet, Headlight - Scratch &amp; Dent - Small / (L) Front Fender, Molding - Scratch &amp; Dent - Minimal / (L) Front Door, Molding - Scratch &amp; Dent - Small / (L) Step, In-panel, Side Spoiler - Scratch &amp; Dent - Minimal / (R) Step, In-panel, Side Spoiler - Scratch &amp; Dent - Minimal / Front Bumper, Grille, Lamps - Scratch - Small</p>
