General Information

| Make | Toyota | Model | Vios |
| Registration No. | NFR6783 | Chassis No. | PA1B18F32R4253109 |

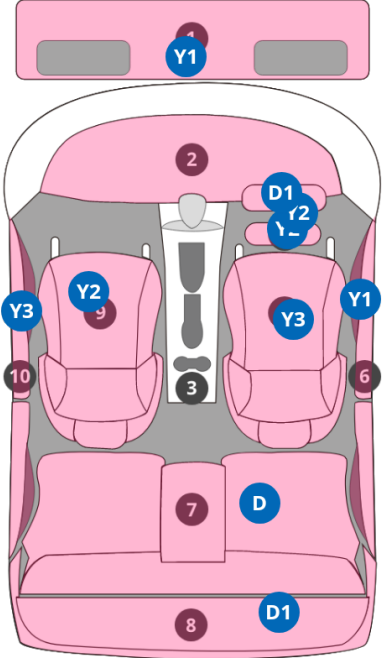
| Interior Evaluation : C | Exterior Evaluation : E |
| <p>Remarks (L) Front Seat - Grime - Small / Rear Seat - Worn - Yes / (R) Front Seat - Grime - Medium / (L) Front Trim - Grime - Medium / (R) Front Trim - Grime - Minimal / (L) Front Floor Mat - Grime - Small / (R) Front Floor Mat - Grime - Small / Trunk Room - Worked - Minimal / Ceiling - Grime - Minimal / Dashboard - Worked - Minimal</p> | <p>Remarks (R) Front Fender - Repair Traces - Yes / (L) Front Fender - Repair Traces - Yes / (L) Rear Door, Molding - Scratch & Dent - Small / (L) Rear Fender, Molding - Scratch & Dent - Small / (L) Front Door, Molding - Scratch & Dent - Medium / Roof - Scratch & Dent - Small / (L) Front Fender, Molding - Scratch & Dent - Small / Front Bumper, Grille, Lamps - Scratch & Dent - Large / Bonnet, Headlight - Scratch & Dent - Small / (R) Front Fender, Molding - Scratch & Dent - Large / (R) Front Door, Molding - Scratch & Dent - Small / (R) Step, In-panel, Side Spoiler - Scratch & Dent - Medium / (R) Rear Door, Molding - Scratch & Dent - Small / (R) Rear Fender, Molding - Scratch & Dent - Medium / Trunk Hood, Rear Gate - Scratch & Dent - Small / Rear Bumper, Lamps, Panels - Scratch & Dent - Small / (L) Step, In-panel, Side Spoiler - Scratch & Dent - Small</p> |

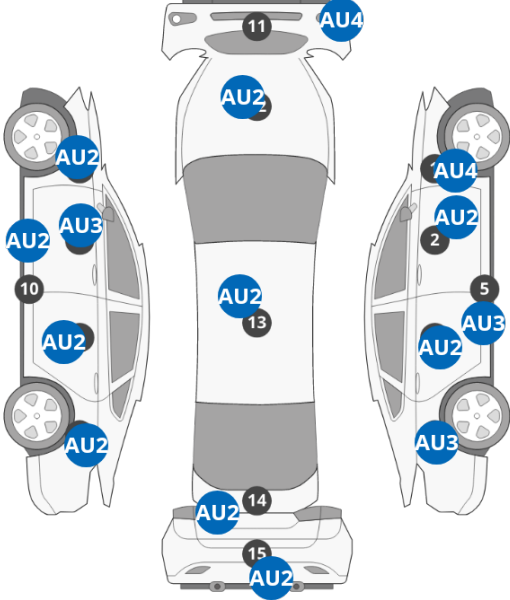
| <p>with LTO plate, with spare tire, with incomplete tools, with manual and warranty booklet, no reverse camera, no jack, scratches on taillight and headlight.</p> |
