## General Information

Date & Time: 02, Mar, 2026 12:25

<b>Make</b>	Toyota	<b>Model</b>	Wigo
<b>YOM</b>	2025	<b>Odo Meter Reading</b>	16,026
<b>Registration No.</b>	NGC9383	<b>Chassis No.</b>	MHKAA1BC6RJ025495
<b>CC</b>	1.0	<b>Transmission</b>	CVT
<b>Fuel Type</b>	Gas	<b>Type of Body</b>	Hatchback
<b>Colour</b>	Gray

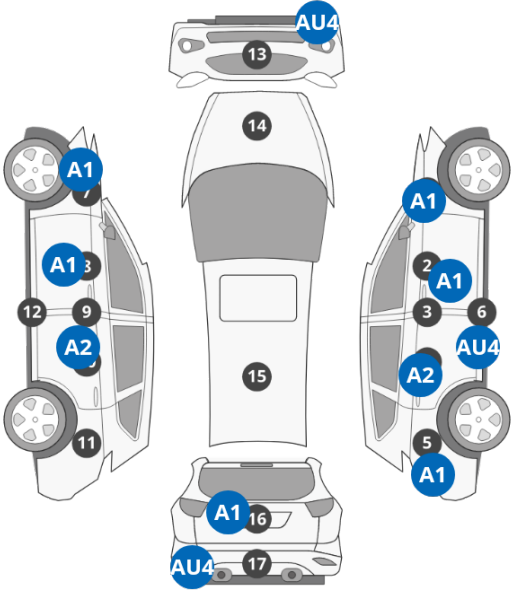
<p><b>A</b> : Scratch <b>AU</b> : Scratch &amp; Dent <b>B</b> : Modified <b>C</b> : Corrosion <b>G</b> : Stone chip <b>P</b> : Faded <b>S</b> : Rust <b>SC</b> : Rust &amp; Corrosion <b>U</b> : Dent <b>X</b> : Defective <b>Y</b> : Crack, Gap</p>
<b>Remarks</b> (L) Front Floor Mat - Worked - Large	<b>Remarks</b> Front Bumper, Grille, Lamps - Scratch & Dent - Large / (R) Step, In-panel, Side Spoiler - Scratch & Dent - Large / Rear Bumper, Lamps, Panels - Scratch & Dent - Large / (L) Rear Door, Molding - Scratch - Small / (L) Front Door, Molding - Scratch - Minimal / (L) Front Fender, Molding - Scratch - Minimal / (R) Front Fender, Molding - Scratch - Minimal / (R) Front Door, Molding - Scratch - Minimal / (R) Rear Door, Molding - Scratch - Small / (R) Rear Fender, Molding - Scratch - Minimal / Trunk Hood, Rear Gate - Scratch - Minimal
