General Information

Make	Toyota	Model	Vios
YOM	2023	Odo Meter Reading	161,263
Registration No.	NHC5236	Chassis No.	PA1B18F34N4197443
CC	1.3	Transmission	CVT
Fuel Type	Gas	Type of Body	Sedan
Colour	Green

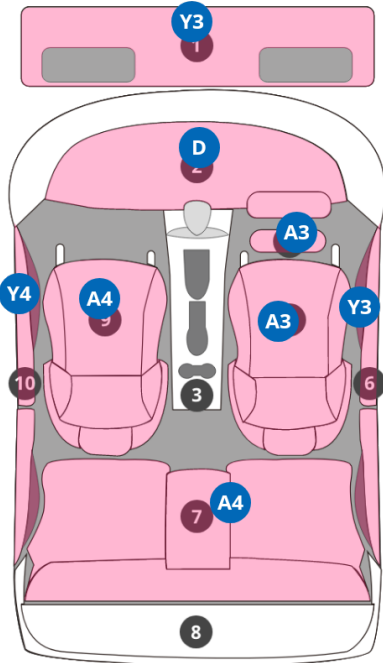
Interior Evaluation : D	Exterior Evaluation : E

<p>a : Cut, Fray d : Loose, Deformed k : Animal Hair s : Smell t : Cigarette Burns x : Defective y : Stain</p>

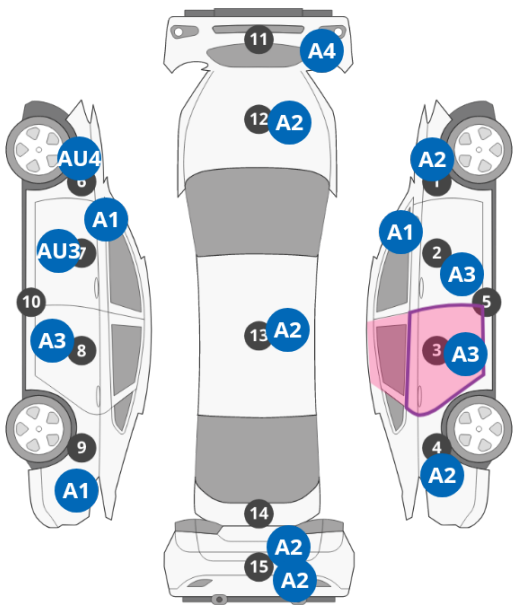
<p>A : Scratch AU : Scratch & Dent B : Modified C : Corrosion G : Stone chip P : Faded S : Rust SC : Rust & Corrosion U : Dent X : Defective Y : Crack, Gap</p>
<p>Remarks (R) Front Seat - Cut, Crack - Medium / (R) Front Trim - Grime - Medium / Rear Seat - Cut, Crack - Large / (L) Front Trim - Grime - Large / (L) Front Seat - Cut, Crack - Large / Dashboard - Traces of Adhesive Tape - Yes / (L) Front Floor Mat - Cut, Crack - Medium / Ceiling - Grime - Medium</p>	<p>Remarks (R) Rear Door - Repair Traces - Yes / Trunk Hood, Rear Gate - Scratch - Small / Rear Bumper, Lamps, Panels - Scratch - Small / (R) Rear Fender, Molding - Scratch - Small / (R) Rear Door, Molding - Scratch - Medium / (R) Front Door, Molding - Scratch - Medium / (R) Mirror - Scratch - Minimal / (R) Front Fender, Molding - Scratch - Small / Front Bumper, Grille, Lamps - Scratch - Large / Bonnet, Headlight - Scratch - Small / (L) Mirror - Scratch - Minimal / (L) Front Fender, Molding - Scratch & Dent - Large / (L) Front Door, Molding - Scratch & Dent - Medium / (L) Rear Door, Molding - Scratch - Medium / (L) Rear Fender, Molding - Scratch - Minimal / Roof - Scratch - Small / (R) Rear Door, Molding - Repair mark - Yes</p>
