## General Information

<b>Make</b>	Toyota	<b>Model</b>	Vios
<b>YOM</b>	2023	<b>Odo Meter Reading</b>	68,002
<b>Registration No.</b>	NHJ2915	<b>Chassis No.</b>	PA1B18F34P4214860
<b>CC</b>	1.3	<b>Transmission</b>	CVT
<b>Fuel Type</b>	Gas	<b>Type of Body</b>	Sedan
<b>Colour</b>	Red Mica Metallic

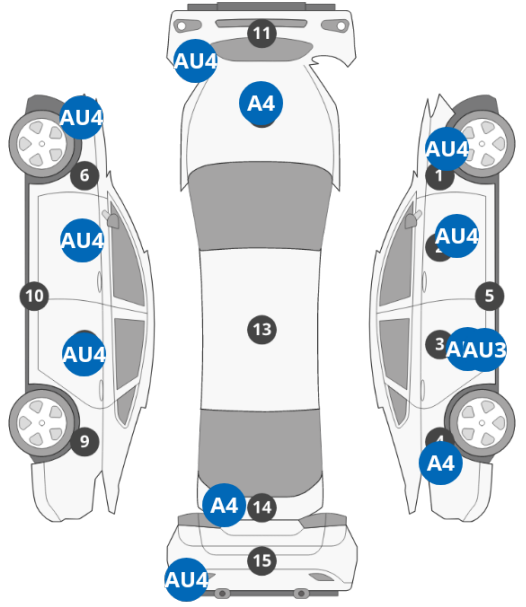
<p><b>A :</b> Scratch <b>AU :</b> Scratch &amp; Dent <b>B :</b> Modified <b>C :</b> Corrosion <b>G :</b> Stone chip <b>P :</b> Faded <b>S :</b> Rust <b>SC :</b> Rust &amp; Corrosion <b>U :</b> Dent <b>X :</b> Defective <b>Y :</b> Crack, Gap</p>
<p><b>Remarks</b> Rear Seat - Grime - Large / (R) Front Trim - Grime - Small / (R) Front Seat - Grime - Large / (L) Front Trim - Grime - Small / (L) Front Seat - Grime - Medium / (L) Front Floor Mat - Worked - Large</p>	<p><b>Remarks</b> Bonnet, Headlight - Scratch - Large / Front Bumper, Grille, Lamps - Scratch &amp; Dent - Large / (L) Front Fender, Molding - Scratch &amp; Dent - Large / (L) Front Door, Molding - Scratch &amp; Dent - Large / (L) Rear Door, Molding - Scratch &amp; Dent - Large / Rear Bumper, Lamps, Panels - Scratch &amp; Dent - Large / Trunk Hood, Rear Gate - Scratch - Large / (R) Rear Fender, Molding - Scratch - Large / (R) Rear Door, Molding - Scratch &amp; Dent - Large / (R) Front Door, Molding - Scratch &amp; Dent - Large / (R) Step, In-panel, Side Spoiler - Scratch &amp; Dent - Medium / (R) Front Fender, Molding - Scratch &amp; Dent - Large</p>
