## General Information

<b>Make</b>	Toyota	<b>Model</b>	Vios
<b>YOM</b>	2023	<b>Odo Meter Reading</b>	29,823
<b>Registration No.</b>	NHJ8540	<b>Chassis No.</b>	PA1B18F30R4218825
<b>CC</b>	1.3	<b>Transmission</b>	M/T
<b>Fuel Type</b>	Gas	<b>Type of Body</b>	Sedan
<b>Colour</b>	Black

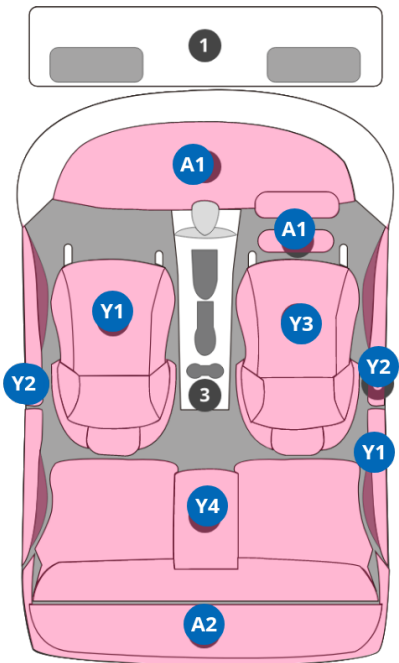
<b>Interior Evaluation :</b> <span style="float: right; color: red; font-weight: bold;">C</span>	<b>Exterior Evaluation :</b> <span style="float: right; color: red; font-weight: bold;">E</span>

<p><b>a</b> : Cut, Fray <b>d</b> : Loose, Deformed <b>k</b> : Animal Hair <b>s</b> : Smell <b>t</b> : Cigarette Burns <b>x</b> : Defective <b>y</b> : Stain</p>

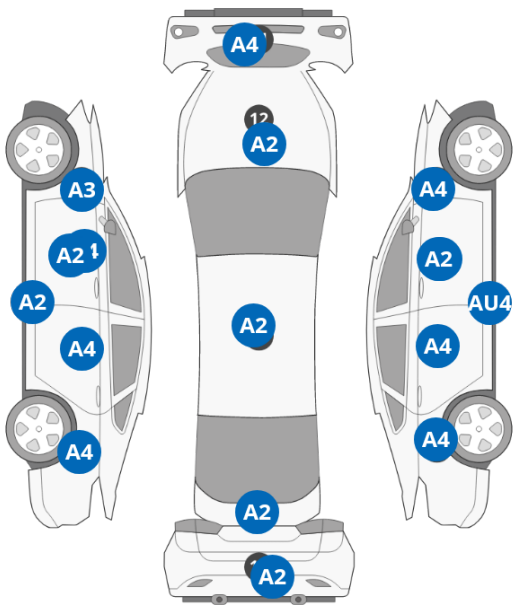
<p><b>A</b> : Scratch <b>AU</b> : Scratch &amp; Dent <b>B</b> : Modified <b>C</b> : Corrosion <b>G</b> : Stone chip <b>P</b> : Faded <b>S</b> : Rust <b>SC</b> : Rust &amp; Corrosion <b>U</b> : Dent <b>X</b> : Defective <b>Y</b> : Crack, Gap</p>
<b>Remarks</b> (R) Front Seat - Grime - Medium / (R) Front Trim - Grime - Small / Rear Seat - Grime - Large / (R) Rear Trim - Grime - Minimal / Trunk Room - Worn, Scratch, Cut, Crack - Small / (L) Rear Trim - Grime - Small / (L) Front Trim - Grime - Small / (L) Front Seat - Grime - Minimal / Carpet - Worn, Scratch, Cut, Crack - Minimal / Dashboard - Worn, Scratch, Cut, Crack - Minimal	<b>Remarks</b> (R) Step, In-panel, Side Spoiler - Scratch & Dent - Large / (R) Rear Door, Molding - Scratch - Large / (R) Front Door, Molding - Scratch - Large / (R) Rear Fender, Molding - Scratch - Large / (L) Rear Fender, Molding - Scratch - Large / Front Bumper, Grille, Lamps - Scratch - Large / Rear Bumper, Lamps, Panels - Scratch - Small / (R) Front Fender, Molding - Scratch - Large / Bonnet, Headlight - Scratch - Small / (L) Front Door, Molding - Scratch - Large / (L) Rear Door, Molding - Scratch - Large / Trunk Hood, Rear Gate - Scratch - Small / Roof - Scratch - Small / (L) Step, In-panel, Side Spoiler - Scratch - Small / (L) Front Fender, Molding - Scratch - Medium / (R) Mirror - Scratch - Small / (L) Mirror - Scratch - Small
