General Information

| Make | Toyota | Model | Innova |
| YOM | 2024 | Odo Meter Reading | 24,903 |

Body / Panel Condition

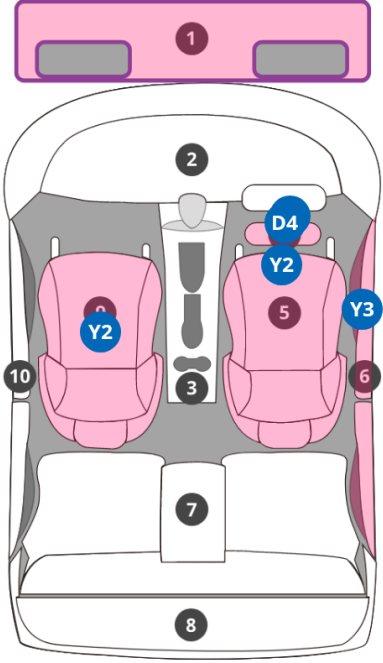
| <p>Remarks (R) Front Seat - Grime - Small / (R) Front Trim - Grime - Medium / (L) Front Seat - Grime - Small / (L) Front Floor Mat - Grime - Small / Room Lamp - Missing - Yes / (L) Front Floor Mat - Worked - Large</p> | <p>Remarks (R) Front Fender, Molding - Scratch - Small / (R) Mirror - Scratch - Small / (R) Front Door, Molding - Scratch - Minimal / (R) Rear Door, Molding - Scratch - Small / (R) Rear Fender, Molding - Scratch - Small / Rear Bumper, Lamps, Panels - Scratch - Small / Trunk Hood, Rear Gate - Scratch - Small / (L) Rear Fender, Molding - Scratch - Small / (L) Rear Door, Molding - Scratch - Small / (L) Front Door, Molding - Scratch - Small / (L) Mirror - Scratch - Minimal / (L) Front Fender, Molding - Scratch - Medium / Bonnet, Headlight - Scratch - Minimal / Front Bumper, Grille, Lamps - Scratch & Dent - Small / Roof - Scratch - Large</p> |
