General Information

Date & Time: 02, Mar, 2026 09:50

Make	Toyota	Model	Vios
YOM	2023	Odo Meter Reading	67,537
Registration No.	NIN8106	Chassis No.	PA1B18F30P4210465
CC	1.3	Transmission	CVT
Fuel Type	Gas	Type of Body	Sedan
Colour	Red

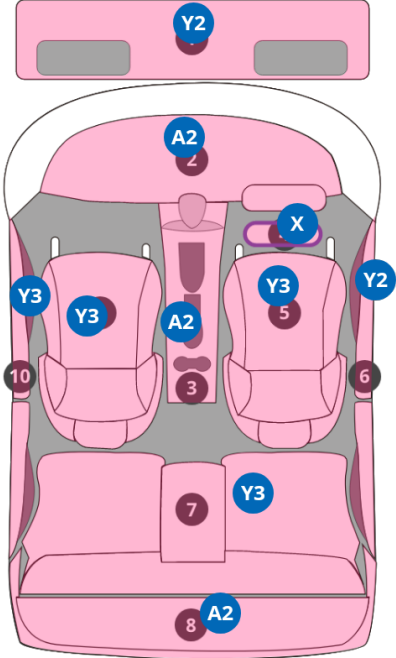
Interior Evaluation : C	Exterior Evaluation : E

<p>a : Cut, Fray d : Loose, Deformed k : Animal Hair s : Smell t : Cigarette Burns x : Defective y : Stain</p>

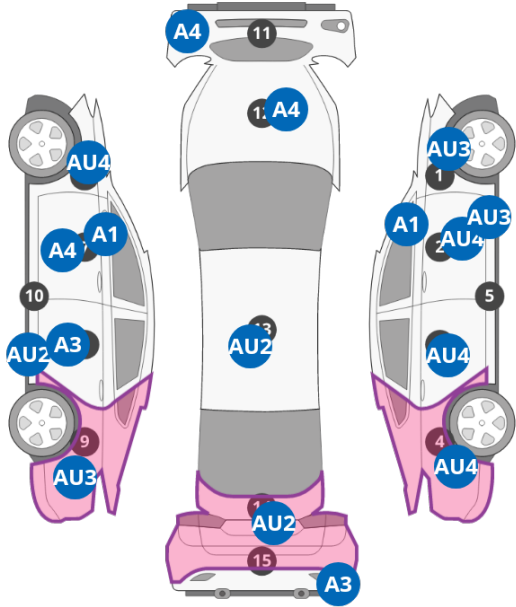
<p>A : Scratch AU : Scratch & Dent B : Modified C : Corrosion G : Stone chip P : Faded S : Rust SC : Rust & Corrosion U : Dent X : Defective Y : Crack, Gap</p>
<p>Remarks (R) Front Seat - Grime - Medium / (R) Front Trim - Grime - Small / Rear Seat - Grime - Medium / Trunk Room - Worn, Scratch, Cut, Crack - Small / (L) Front Trim - Grime - Medium / (L) Front Seat - Grime - Medium / (L) Front Floor Mat - Missing - Yes / Dashboard - Worn, Scratch, Cut, Crack - Small / Ceiling - Grime - Small / Console, Switches, Vents - Worn, Scratch, Cut, Crack - Small</p>	<p>Remarks (L) Rear Fender - Repair Traces - Yes / Trunk Hood, Rear Gate - Repair Traces - Yes / (R) Rear Fender - Repair Traces - Yes / Trunk Hood, Rear Gate - Scratch & Dent - Small / Rear Bumper, Lamps, Panels - Scratch - Medium / (R) Rear Fender, Molding - Scratch & Dent - Large / (R) Rear Door, Molding - Scratch & Dent - Large / (R) Front Door, Molding - Scratch & Dent - Large / (R) Step, In-panel, Side Spoiler - Scratch & Dent - Medium / (R) Mirror - Scratch - Minimal / (R) Front Fender, Molding - Scratch & Dent - Medium / Bonnet, Headlight - Scratch - Large / Front Bumper, Grille, Lamps - Scratch - Large / (L) Front Fender, Molding - Scratch & Dent - Large / (L) Mirror - Scratch - Minimal / (L) Front Door, Molding - Scratch - Large / (L) Step, In-panel, Side Spoiler - Scratch & Dent - Small / (L) Rear Door, Molding - Scratch - Medium / (L) Rear Fender, Molding - Scratch & Dent - Medium / Roof - Scratch & Dent - Small / (L) Rear Fender, Molding - Repair mark - Yes / Trunk Hood, Rear Gate - Repair mark - Yes / (R) Rear Fender, Molding - Repair mark - Yes</p>
