## General Information

<b>Make</b>	Toyota	<b>Model</b>	Vios
<b>YOM</b>	2025	<b>Odo Meter Reading</b>	35,036
<b>Registration No.</b>	NKJ8825	<b>Chassis No.</b>	PA1B18F34R4267688
<b>CC</b>	1.3	<b>Transmission</b>	CVT
<b>Fuel Type</b>	Gas	<b>Type of Body</b>	Sedan
<b>Colour</b>	Blue

## Body / Panel Condition

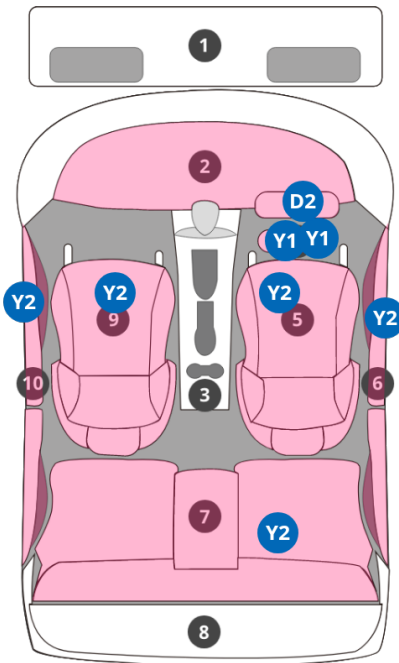
<b>Interior Evaluation :</b> <span style="float: right;"><b>B</b></span>	<b>Exterior Evaluation :</b> <span style="float: right;"><b>E</b></span>

<p><b>a</b> : Cut, Fray <b>d</b> : Loose, Deformed <b>k</b> : Animal Hair <b>s</b> : Smell <b>t</b> : Cigarette Burns <b>x</b> : Defective <b>y</b> : Stain</p>

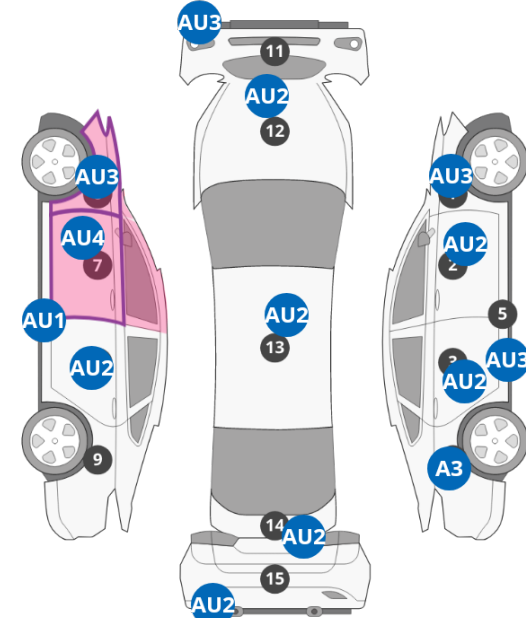
<p><b>A</b> : Scratch <b>AU</b> : Scratch &amp; Dent <b>B</b> : Modified <b>C</b> : Corrosion <b>G</b> : Stone chip <b>P</b> : Faded <b>S</b> : Rust <b>SC</b> : Rust &amp; Corrosion <b>U</b> : Dent <b>X</b> : Defective <b>Y</b> : Crack, Gap</p>
<p><b>Remarks</b> (L) Front Seat - Grime - Small / (R) Front Seat - Grime - Small / Rear Seat - Grime - Small / (R) Front Floor Mat - Grime - Minimal / (L) Front Floor Mat - Grime - Minimal / Glove Box - Loose, Deformed - Small / (L) Front Trim - Grime - Small / (R) Front Trim - Grime - Small</p>	<p><b>Remarks</b> (R) Front Fender - Repair Traces - Yes / (L) Front Fender - Repair Traces - Yes / Roof - Scratch &amp; Dent - Small / (L) Front Door, Molding - Scratch &amp; Dent - Large / (L) Front Fender, Molding - Repair mark - Yes / (L) Front Door, Molding - Repair mark - Yes / (L) Front Fender, Molding - Scratch &amp; Dent - Medium / Bonnet, Headlight - Scratch &amp; Dent - Small / Front Bumper, Grille, Lamps - Scratch &amp; Dent - Medium / (R) Front Fender, Molding - Scratch &amp; Dent - Medium / (R) Step, In-panel, Side Spoiler - Scratch &amp; Dent - Medium / (R) Front Door, Molding - Scratch &amp; Dent - Small / (R) Rear Door, Molding - Scratch &amp; Dent - Small / (R) Rear Fender, Molding - Scratch - Medium / Trunk Hood, Rear Gate - Scratch &amp; Dent - Small / Rear Bumper, Lamps, Panels - Scratch &amp; Dent - Small / (L) Rear Door, Molding - Scratch &amp; Dent - Small / (L) Step, In-panel, Side Spoiler - Scratch &amp; Dent - Minimal</p>
