## General Information

<b>Make</b>	Toyota	<b>Model</b>	Veloz
<b>YOM</b>	2025	<b>Odo Meter Reading</b>	19,800
<b>Registration No.</b>	NOA4417	<b>Chassis No.</b>	MHFAB1BY0S3133659
<b>CC</b>	1.5	<b>Transmission</b>	CVT
<b>Fuel Type</b>	Gas	<b>Type of Body</b>	SUV
<b>Colour</b>	Black

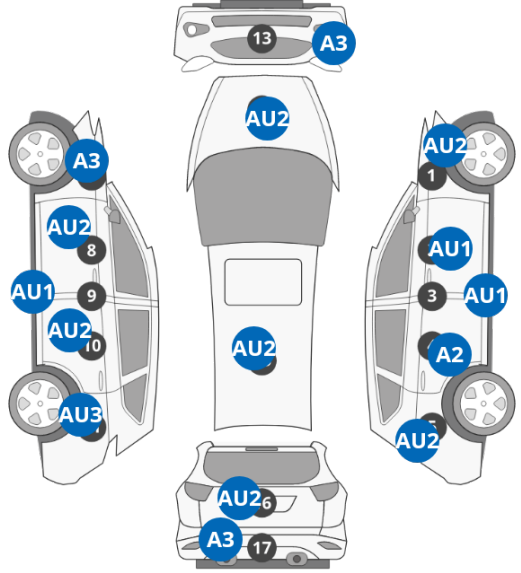
<p><b>A</b> : Scratch <b>AU</b> : Scratch &amp; Dent <b>B</b> : Modified <b>C</b> : Corrosion <b>G</b> : Stone chip <b>P</b> : Faded <b>S</b> : Rust <b>SC</b> : Rust &amp; Corrosion <b>U</b> : Dent <b>X</b> : Defective <b>Y</b> : Crack, Gap</p>
<p><b>Remarks</b> (L) Front Seat - Grime - Small / (R) Front Seat - Grime - Small / Mat Other - Missing - Yes / (R) Front Floor Mat - Missing - Yes / (L) Front Floor Mat - Missing - Yes / Rear Seat - Grime - Minimal / (L) Front Trim - Grime - Small / (R) Front Trim - Grime - Small / Ceiling - Grime - Minimal</p>	<p><b>Remarks</b> (L) Front Fender, Molding - Scratch - Medium / (L) Front Door, Molding - Scratch &amp; Dent - Small / (L) Rear Door, Molding - Scratch &amp; Dent - Small / (L) Rear Fender, Molding - Scratch &amp; Dent - Medium / Rear Bumper, Lamps, Panels - Scratch - Medium / Trunk Hood, Rear Gate - Scratch &amp; Dent - Small / (R) Rear Door, Molding - Scratch - Small / (R) Front Door, Molding - Scratch &amp; Dent - Minimal / (R) Front Fender, Molding - Scratch &amp; Dent - Small / Bonnet, Headlight - Scratch &amp; Dent - Small / Front Bumper, Grille, Lamps - Scratch - Medium / (R) Rear Fender, Molding - Scratch &amp; Dent - Small / Roof - Scratch &amp; Dent - Small / (L) Step, In-panel, Side Spoiler - Scratch &amp; Dent - Minimal / (R) Step, In-panel, Side Spoiler - Scratch &amp; Dent - Minimal</p>
