General Information

| Make | Toyota | Model | Vios |
| Registration No. | DAV6489 | Chassis No. | PA1B18F3XM4149413 |

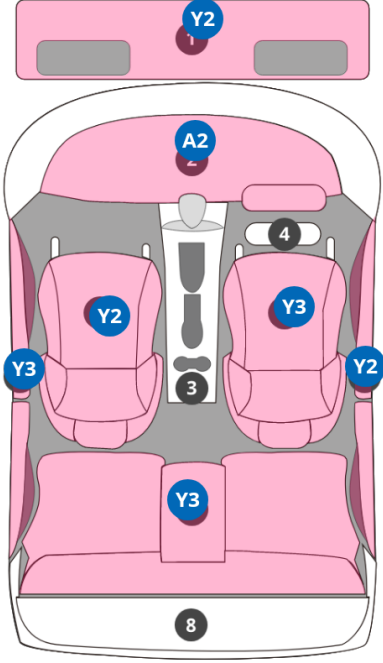
| <p>Remarks (R) Front Seat - Grime - Medium / (R) Front Trim - Grime - Small / Rear Seat - Grime - Medium / (L) Front Trim - Grime - Medium / (L) Front Seat - Grime - Small / Ceiling - Grime - Small / Dashboard - Worn, Scratch, Cut, Crack - Small</p> | <p>Remarks (R) Front Door - Repair Traces - Yes / (R) Front Fender - Repair Traces - Yes / Bonnet - Repair Traces - Yes / (L) Front Fender - Repair Traces - Yes / (L) Front Door - Repair Traces - Yes / (L) Rear Door - Repair Traces - Yes / (L) Rear Fender - Repair Traces - Yes / Trunk Hood, Rear Gate - Repair Traces - Yes / (R) Rear Fender - Repair Traces - Yes / (R) Rear Door - Repair Traces - Yes / Roof - Repair Traces - Yes / Trunk Hood, Rear Gate - Scratch - Small / Rear Bumper, Lamps, Panels - Scratch - Large / (R) Rear Fender, Molding - Scratch - Small / (R) Rear Door, Molding - Scratch - Medium / (R) Front Door, Molding - Scratch - Large / (R) Front Fender, Molding - Scratch - Small / Bonnet, Headlight - Scratch - Medium / Front Bumper, Grille, Lamps - Scratch - Medium / (L) Front Fender, Molding - Scratch - Small / (L) Front Door, Molding - Scratch - Small / (L) Rear Door, Molding - Scratch - Large / (L) Rear Fender, Molding - Scratch - Medium / Roof - Scratch - Small</p> |
