General Information

| Make | Mitsubishi | Model | Xpander Cross |
| Registration No. | IAF1530 | Chassis No. | MK2XRNC1WPN00602 |

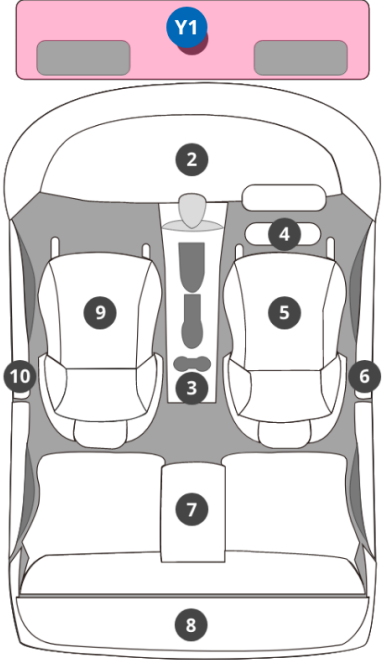
| Interior Evaluation : A | Exterior Evaluation : C |
| Remarks Ceiling - Grime - Minimal | Remarks (L) Rear Fender - Repair Traces - Yes / (R) Front Fender, Molding - Scratch - Minimal / (R) Mirror - Scratch - Minimal / (R) Front Door, Molding - Scratch - Minimal / (R) Step, In-panel, Side Spoiler - Scratch - Minimal / (R) Rear Door, Molding - Scratch - Minimal / (R) Rear Fender, Molding - Scratch - Minimal / Rear Bumper, Lamps, Panels - Scratch - Minimal / Trunk Hood, Rear Gate - Scratch - Minimal / Roof - Scratch - Minimal / (L) Rear Fender, Molding - Repair mark - Yes / (L) Rear Fender, Molding - Scratch - Minimal / (L) Rear Door, Molding - Scratch - Minimal / (L) Front Door, Molding - Scratch - Small / (L) Step, In-panel, Side Spoiler - Scratch - Medium / (L) Front Fender, Molding - Scratch - Small / Front Bumper, Grille, Lamps - Scratch - Minimal / Bonnet, Headlight - Scratch - Minimal |

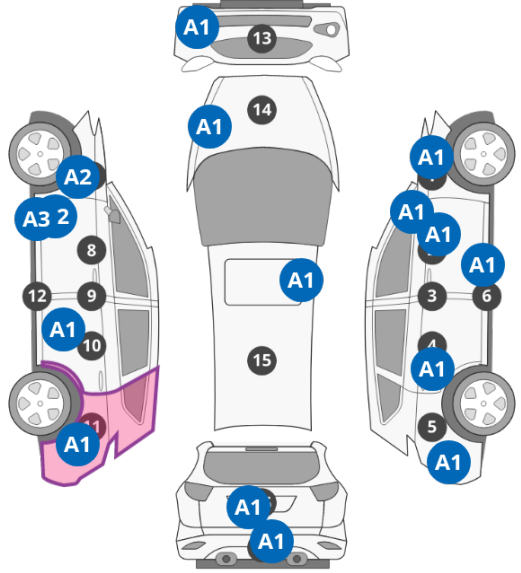
| With Lto plate, with warranty booklet, with spare tire and jack, 1key, no tools, scratches on headlights and taillights, warning lamp on |
