General Information

Make	Mitsubishi	Model	Mirage
YOM	2018	Odo Meter Reading	102,659
Registration No.	NCS8950	Chassis No.	PAFA131JJA0M196
CC	1.2	Transmission	A/T
Fuel Type	Gas	Type of Body	Sedan
Colour	Red

Body / Panel Condition

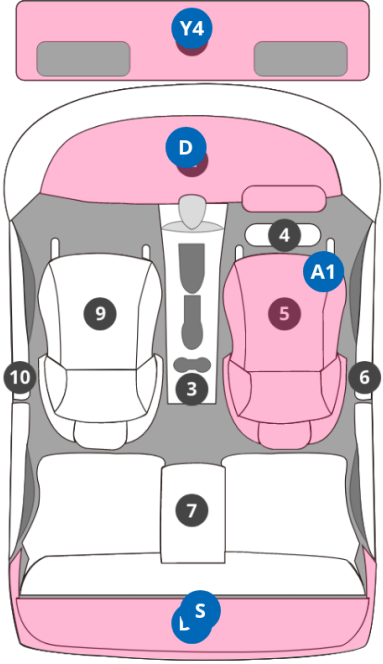
Interior Evaluation : C	Exterior Evaluation : E
<div style="text-align: center;">

</div> <p>a : Cut, Fray d : Loose, Deformed k : Animal Hair s : Smell t : Cigarette Burns x : Defective y : Stain</p>	<div style="text-align: center;">

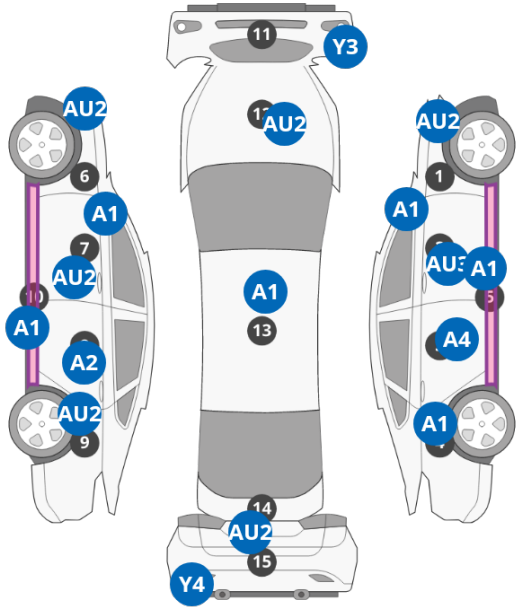
</div> <p>A : Scratch AU : Scratch & Dent B : Modified C : Corrosion G : Stone chip P : Faded S : Rust SC : Rust & Corrosion U : Dent X : Defective Y : Crack, Gap</p>
<p>Remarks Ceiling - Grime - Large / Dashboard - Traces of Adhesive Tape - Yes / (R) Front Seat - Cut, Crack - Minimal / Trunk Room - Loose, Deformed - Large / Overall Interior - Smell - Yes</p>	<p>Remarks (R) Front Door - Repair Traces - Yes / (R) Step - Repair Traces - Yes / (R) Front Fender - Repair Traces - Yes / Bonnet - Repair Traces - Yes / (L) Front Fender - Repair Traces - Yes / (L) Front Door - Repair Traces - Yes / (L) Step - Repair Traces - Yes / (L) Rear Door - Repair Traces - Yes / (L) Rear Fender - Repair Traces - Yes / Trunk Hood, Rear Gate - Repair Traces - Yes / (R) Rear Fender - Repair Traces - Yes / (R) Rear Door - Repair Traces - Yes / Roof - Repair Traces - Yes / Overall Exterior - Full Re-Paint in same color - Yes / (R) Front Fender, Molding - Scratch & Dent - Small / (R) Mirror - Scratch - Minimal / (R) Front Door, Molding - Scratch & Dent - Medium / (R) Rear Door, Molding - Scratch - Large / (R) Rear Fender, Molding - Scratch - Minimal / Rear Bumper, Lamps, Panels - Crack, Gap - Large / Trunk Hood, Rear Gate - Scratch & Dent - Small / (R) Step, In-panel, Side Spoiler - Repair mark - Yes / (R) Step, In-panel, Side Spoiler - Scratch - Minimal / (L) Rear Fender, Molding - Scratch & Dent - Small / (L) Rear Door, Molding - Scratch - Small / (L) Step, In-panel, Side Spoiler - Repair mark - Yes / (L) Step, In-panel, Side Spoiler - Scratch - Minimal / (L) Front Door, Molding - Scratch & Dent - Small / (L) Mirror - Scratch - Minimal / (L) Front Fender, Molding - Scratch & Dent - Small / Front Bumper, Grille, Lamps - Crack, Gap - Medium / Bonnet, Headlight - Scratch & Dent - Small / Roof - Scratch - Minimal</p>
