## General Information

Date & Time: 02, Mar, 2026 11:50

<b>Make</b>	Mitsubishi	<b>Model</b>	L300
<b>YOM</b>	2017	<b>Odo Meter Reading</b>	74,857
<b>Registration No.</b>	NAW1269	<b>Chassis No.</b>	PAEL35NYHGB003513
<b>CC</b>	2.5	<b>Transmission</b>	M/T
<b>Fuel Type</b>	Diesel	<b>Type of Body</b>	FB Body
<b>Colour</b>	White

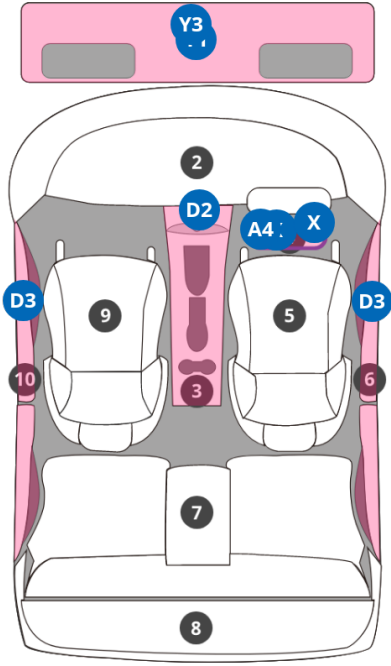
<b>Interior Evaluation :</b> <span style="float: right; color: red; font-weight: bold;">C</span>	<b>Exterior Evaluation :</b> <span style="float: right; color: red; font-weight: bold;">E</span>

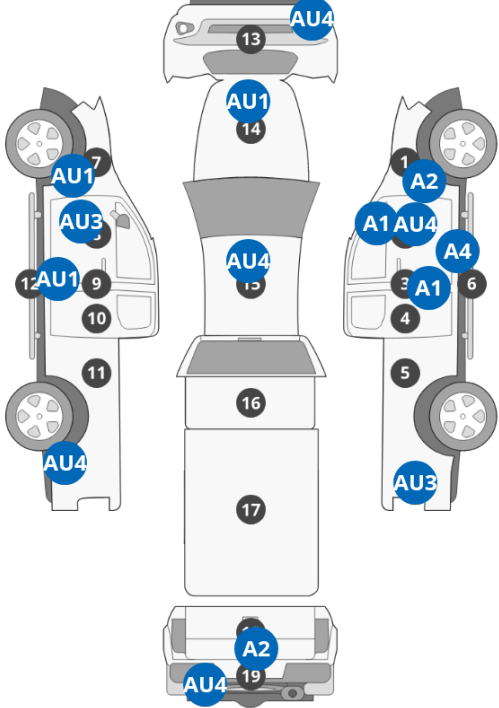
<p><b>A</b> : Scratch <b>AU</b> : Scratch &amp; Dent <b>B</b> : Modified <b>C</b> : Corrosion <b>G</b> : Stone chip <b>P</b> : Faded <b>S</b> : Rust <b>SC</b> : Rust &amp; Corrosion <b>U</b> : Dent <b>X</b> : Defective <b>Y</b> : Crack, Gap</p>
<p><b>Remarks</b> Ceiling - Grime - Minimal / Sunvisor, Sunglass Holder - Grime - Medium / (R) Front Floor Mat - Missing - Yes / (L) Front Floor Mat - Missing - Yes / Carpet - Worn, Scratch, Cut, Crack - Large / (R) Front Trim - Loose, Deformed - Medium / (L) Front Trim - Loose, Deformed - Medium / Console, Switches, Vents - Loose, Deformed - Small</p>	<p><b>Remarks</b> (R) Front Fender, Molding - Scratch - Small / (R) Mirror - Scratch - Minimal / (R) Front Door, Molding - Scratch &amp; Dent - Large / (R) Step, In-panel, Side Spoiler - Scratch - Large / (R) Center Panel - Scratch - Minimal / (R) Side Gate - Scratch &amp; Dent - Medium / Rear Gate - Scratch - Small / Rear Bumper, Lamps, Panels - Scratch &amp; Dent - Large / (L) Side Gate - Scratch &amp; Dent - Large / (L) Center Panel - Scratch &amp; Dent - Minimal / (L) Front Door, Molding - Scratch &amp; Dent - Medium / (L) Front Fender, Molding - Scratch &amp; Dent - Minimal / Front Bumper, Grille, Lamps - Scratch &amp; Dent - Large / Front Panel - Scratch &amp; Dent - Minimal / Roof - Scratch &amp; Dent - Large</p>
