## General Information

Date & Time: 27, Feb, 2026 18:55

<b>Make</b>	Toyota	<b>Model</b>	Vios
<b>YOM</b>	2021	<b>Odo Meter Reading</b>	40,609
<b>Registration No.</b>	DAV7954	<b>Chassis No.</b>	PA1B1837M4152317
<b>CC</b>	1.3	<b>Transmission</b>	CVT
<b>Fuel Type</b>	Gas	<b>Type of Body</b>	Sedan
<b>Colour</b>	Silver

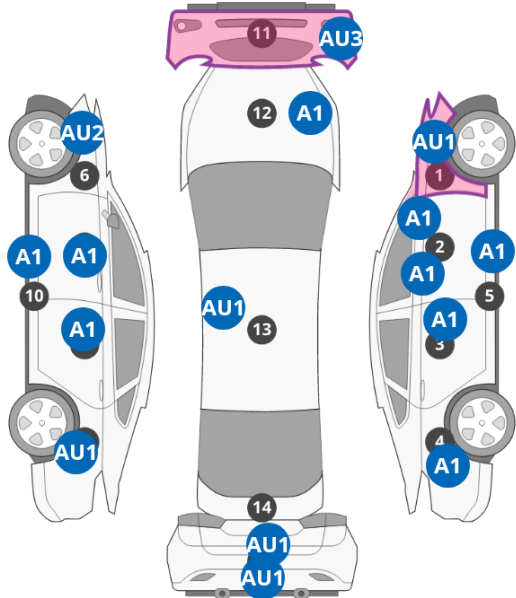
<p><b>A</b> : Scratch <b>AU</b> : Scratch &amp; Dent <b>B</b> : Modified <b>C</b> : Corrosion <b>G</b> : Stone chip <b>P</b> : Faded <b>S</b> : Rust <b>SC</b> : Rust &amp; Corrosion <b>U</b> : Dent <b>X</b> : Defective <b>Y</b> : Crack, Gap</p>
<p><b>Remarks</b> Ceiling - Grime - Minimal / (R) Front Trim - Grime - Minimal / (L) Front Seat - Grime - Minimal / Trunk Room - Loose, Deformed - Large</p>	<p><b>Remarks</b> Bonnet - Repair Traces - Yes / Trunk Hood, Rear Gate - Repair Traces - Yes / (R) Front Fender, Molding - Repair mark - Yes / (R) Front Fender, Molding - Scratch &amp; Dent - Minimal / (R) Mirror - Scratch - Minimal / (R) Front Door, Molding - Scratch - Minimal / (R) Step, In-panel, Side Spoiler - Scratch - Minimal / (R) Rear Door, Molding - Scratch - Minimal / (R) Rear Fender, Molding - Scratch - Minimal / Rear Bumper, Lamps, Panels - Scratch &amp; Dent - Minimal / Trunk Hood, Rear Gate - Scratch &amp; Dent - Minimal / (L) Rear Fender, Molding - Scratch &amp; Dent - Minimal / (L) Rear Door, Molding - Scratch - Minimal / (L) Step, In-panel, Side Spoiler - Scratch - Minimal / (L) Front Door, Molding - Scratch - Minimal / (L) Front Fender, Molding - Scratch &amp; Dent - Small / Front Bumper, Grille, Lamps - Scratch &amp; Dent - Medium / Front Bumper, Grille, Lamps - Repair mark - Yes / Bonnet, Headlight - Scratch - Minimal / Roof - Scratch &amp; Dent - Minimal</p>
