## General Information

| Make | Toyota | Model | Vios |
| YOM | 2023 | Mileage | 54,705 |
| Registration No. | NHF2251 | Chassis No. | PA1B18F39P4216877 |

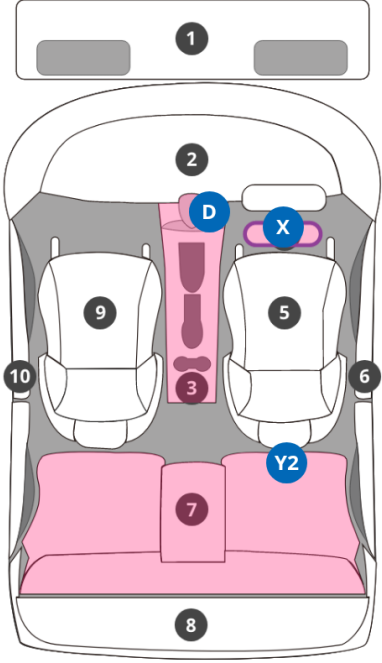
| Interior Evaluation : <b>B</b> | Exterior Evaluation : <b>B</b> |
|---|---|
| <p><b>Remarks</b><br/>Console, Switches, Vents - Traces of Adhesive Tape - Yes / Mat Other - Missing - Yes / Rear Seat - Grime - Small</p> | <p><b>Remarks</b><br/>Member (Bolted) - Dent - Yes / (R) Front Door, Molding - Scratch &amp; Dent - Minimal / (L) Rear Door, Molding - Scratch - Small / (L) Mirror - Scratch - Small / (R) Rear Fender, Molding - Scratch - Medium / Front Bumper, Grille, Lamps - Scratch - Medium / (R) Front Fender, Molding - Scratch - Small</p> |
