## General Information

Date & Time: 27, Feb, 2026 14:24

<b>Make</b>	Honda	<b>Model</b>	City
<b>YOM</b>	2020	<b>Odo Meter Reading</b>	66,111
<b>Registration No.</b>	NDM3937	<b>Chassis No.</b>	PADGM6620LV618598
<b>CC</b>	1.5	<b>Transmission</b>	A/T
<b>Fuel Type</b>	Gas	<b>Type of Body</b>	Sedan
<b>Colour</b>	Gray

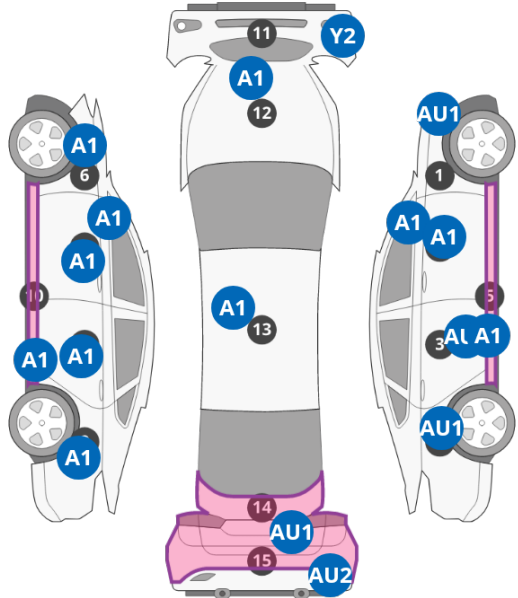
<p><b>A</b> : Scratch <b>AU</b> : Scratch &amp; Dent <b>B</b> : Modified <b>C</b> : Corrosion <b>G</b> : Stone chip <b>P</b> : Faded <b>S</b> : Rust <b>SC</b> : Rust &amp; Corrosion <b>U</b> : Dent <b>X</b> : Defective <b>Y</b> : Crack, Gap</p>
<b>Remarks</b> Ceiling - Grime - Small / Trunk Room - Loose, Deformed - Medium	<b>Remarks</b> (R) Front Door - Repair Traces - Yes / (R) Step - Repair Traces - Yes / (R) Front Fender - Repair Traces - Yes / Trunk Hood, Rear Gate - Repair Traces - Yes / Roof - Repair Traces - Yes / (R) Front Fender, Molding - Scratch & Dent - Minimal / (R) Mirror - Scratch - Minimal / (R) Step, In-panel, Side Spoiler - Repair mark - Yes / (R) Front Door, Molding - Scratch - Minimal / (R) Rear Door, Molding - Scratch & Dent - Minimal / (R) Rear Fender, Molding - Scratch & Dent - Minimal / (R) Step, In-panel, Side Spoiler - Scratch - Minimal / Trunk Hood, Rear Gate - Scratch & Dent - Minimal / Rear Bumper, Lamps, Panels - Scratch & Dent - Small / (L) Rear Fender, Molding - Scratch - Minimal / Trunk Hood, Rear Gate - Repair mark - Yes / (L) Rear Door, Molding - Scratch - Minimal / (L) Step, In-panel, Side Spoiler - Repair mark - Yes / (L) Step, In-panel, Side Spoiler - Scratch - Minimal / (L) Front Door, Molding - Scratch - Minimal / (L) Mirror - Scratch - Minimal / (L) Front Fender, Molding - Scratch - Minimal / Front Bumper, Grille, Lamps - Crack, Gap - Small / Bonnet, Headlight - Scratch - Minimal / Roof - Scratch - Minimal
