General Information

Make	Ford	Model	Ranger
YOM	2017	Odo Meter Reading	94,891
Registration No.	NBC1779	Chassis No.	MNCUMFF50HW737304
CC	3.2	Transmission	M/T
Fuel Type	Diesel	Type of Body	Pickup
Colour	White

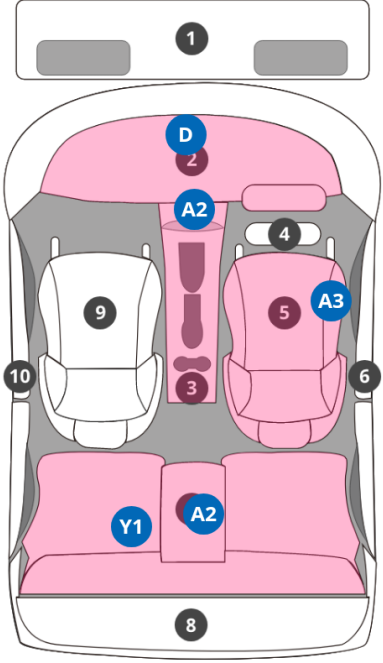
Interior Evaluation : B	Exterior Evaluation : D

<p>a : Cut, Fray d : Loose, Deformed k : Animal Hair s : Smell t : Cigarette Burns x : Defective y : Stain</p>

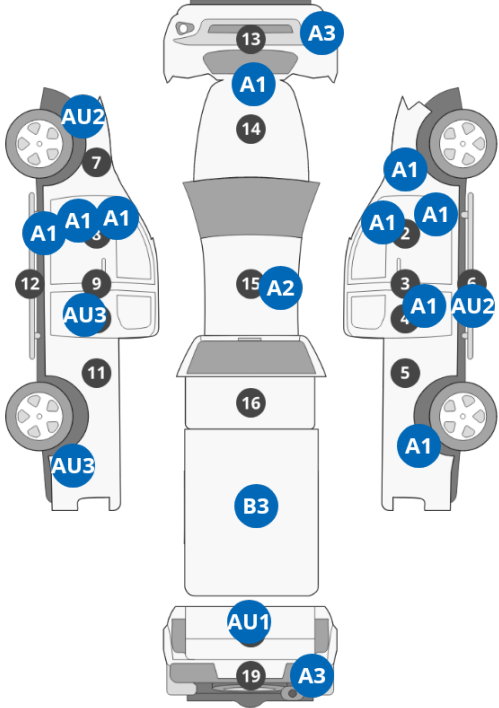
<p>A : Scratch AU : Scratch & Dent B : Modified C : Corrosion G : Stone chip P : Faded S : Rust SC : Rust & Corrosion U : Dent X : Defective Y : Crack, Gap</p>
<p>Remarks (R) Front Seat - Cut, Crack - Medium / Knobs - Worn, Peel, Crack - Small / Dashboard - Traces of Adhesive Tape - Yes / Rear Seat - Grime - Minimal / Seat belt Other - Cut, Crack - Small</p>	<p>Remarks (R) Front Door - Repair Traces - Yes / (R) Front Fender - Repair Traces - Yes / Bonnet - Repair Traces - Yes / (L) Front Fender - Repair Traces - Yes / (L) Front Door - Repair Traces - Yes / (L) Rear Door - Repair Traces - Yes / (L) Rear Corner Panel - Repair Traces - Yes / (R) Rear Door - Repair Traces - Yes / Roof - Repair Traces - Yes / Overall Exterior - Full Re-Paint in same color - Yes / (R) Front Fender, Molding - Scratch - Minimal / (R) Mirror - Scratch - Minimal / (R) Front Door, Molding - Scratch - Minimal / Roof - Scratch - Small / (R) Step, In-panel, Side Spoiler - Scratch & Dent - Small / (R) Rear Door, Molding - Scratch - Minimal / (R) Side Gate - Scratch - Minimal / Cab Back Panel - Modified - Medium / Rear Gate - Scratch & Dent - Minimal / Rear Bumper, Lamps, Panels - Scratch - Medium / (L) Side Gate - Scratch & Dent - Medium / (L) Rear Door, Molding - Scratch & Dent - Medium / (L) Front Door, Molding - Scratch - Minimal / (L) Step, In-panel, Side Spoiler - Scratch - Minimal / (L) Front Fender, Molding - Scratch & Dent - Small / Front Bumper, Grille, Lamps - Scratch - Medium / Bonnet, Headlight - Scratch - Minimal / (L) Mirror - Scratch - Minimal</p>
