## General Information

<b>Make</b>	Toyota	<b>Model</b>	Vios
<b>YOM</b>	2025	<b>Odo Meter Reading</b>	9,395
<b>Registration No.</b>	DBS6737	<b>Chassis No.</b>	PA1B18F38S4282295
<b>CC</b>	1.3	<b>Transmission</b>	CVT
<b>Fuel Type</b>	Gas	<b>Type of Body</b>	Sedan
<b>Colour</b>	Blue

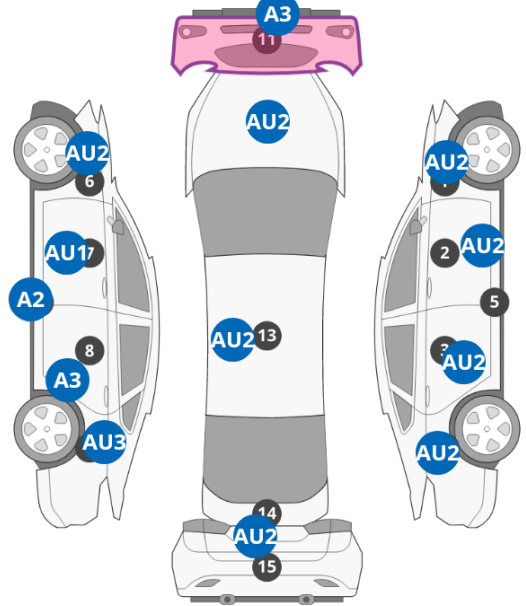
<p><b>A</b> : Scratch <b>AU</b> : Scratch &amp; Dent <b>B</b> : Modified <b>C</b> : Corrosion <b>G</b> : Stone chip <b>P</b> : Faded <b>S</b> : Rust <b>SC</b> : Rust &amp; Corrosion <b>U</b> : Dent <b>X</b> : Defective <b>Y</b> : Crack, Gap</p>
<p><b>Remarks</b> (L) Front Seat - Grime - Small / (R) Front Seat - Grime - Small / (L) Front Trim - Grime - Small / (R) Front Trim - Grime - Small / Rear Seat - Grime - Small</p>	<p><b>Remarks</b> Roof - Scratch &amp; Dent - Small / (L) Rear Door, Molding - Scratch - Medium / (L) Front Door, Molding - Scratch &amp; Dent - Minimal / (L) Step, In-panel, Side Spoiler - Scratch - Small / Trunk Hood, Rear Gate - Scratch &amp; Dent - Small / (R) Rear Fender, Molding - Scratch &amp; Dent - Small / (L) Rear Fender, Molding - Scratch &amp; Dent - Medium / (R) Rear Door, Molding - Scratch &amp; Dent - Small / (R) Front Door, Molding - Scratch &amp; Dent - Small / (R) Front Fender, Molding - Scratch &amp; Dent - Small / Bonnet, Headlight - Scratch &amp; Dent - Small / Front Bumper, Grille, Lamps - Scratch - Medium / (L) Front Fender, Molding - Scratch &amp; Dent - Small / Front Bumper, Grille, Lamps - Repair mark - Yes</p>
