General Information

| Make | Toyota | Model | Wigo |
| Registration No. | DBT2092 | Chassis No. | MHKAA1BC7RJ034108 |

Body / Panel Condition

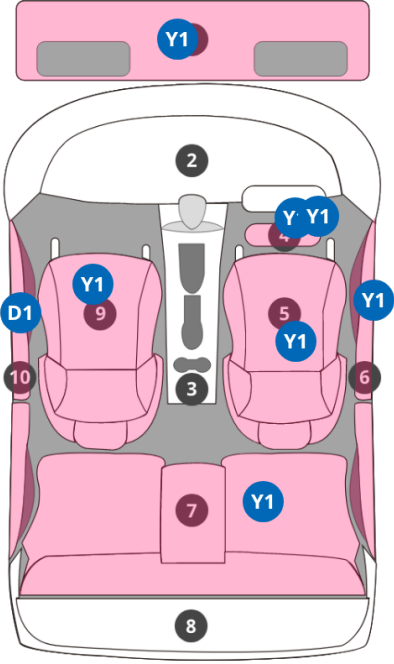
| Interior Evaluation : A | Exterior Evaluation : D |
| <p>Remarks (L) Front Trim - Crinkle - Minimal / (R) Front Trim - Grime - Minimal / (L) Front Seat - Grime - Minimal / (L) Front Floor Mat - Grime - Minimal / (R) Front Floor Mat - Grime - Minimal / Rear Seat - Grime - Minimal / (R) Front Seat - Grime - Minimal / Ceiling - Grime - Minimal</p> | <p>Remarks Trunk Hood, Rear Gate - Scratch & Dent - Small / Rear Bumper, Lamps, Panels - Scratch - Small / (L) Rear Fender, Molding - Scratch & Dent - Minimal / (L) Rear Door, Molding - Scratch & Dent - Minimal / Roof - Scratch & Dent - Small / (L) Front Door, Molding - Scratch & Dent - Minimal / (L) Front Fender, Molding - Scratch & Dent - Large / Bonnet, Headlight - Scratch & Dent - Medium / Front Bumper, Grille, Lamps - Scratch - Medium / (R) Front Fender, Molding - Scratch & Dent - Small / (R) Front Door, Molding - Scratch & Dent - Small / (R) Rear Door, Molding - Scratch & Dent - Small / (R) Step, In-panel, Side Spoiler - Scratch & Dent - Small / (R) Rear Fender, Molding - Scratch & Dent - Small</p> |

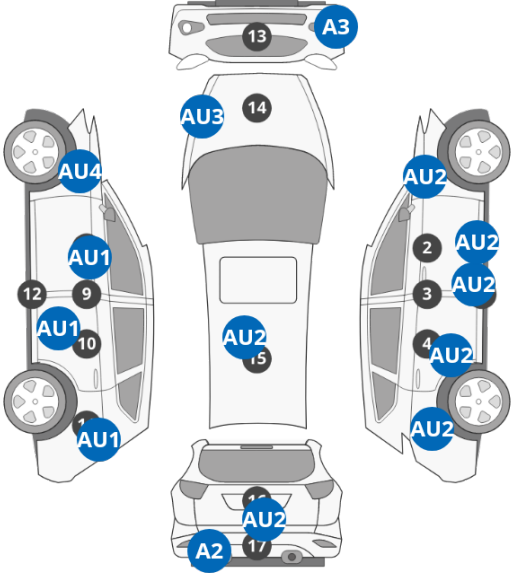
| <p>with LTO plate, with spare tire, with jack and inc tools, with manual and warranty booklet, no spare key, no reverse camera, scratches on taillight and headlight, issue on sidemirror driver side.</p> |
