## General Information

<b>Make</b>	Toyota	<b>Model</b>	Hilux
<b>YOM</b>	2024	<b>Odo Meter Reading</b>	18,040
<b>Registration No.</b>	NFC5024	<b>Chassis No.</b>	MR0JB8DD2P3550708
<b>CC</b>	2.4	<b>Transmission</b>	A/T
<b>Fuel Type</b>	Diesel	<b>Type of Body</b>	Pickup
<b>Colour</b>	Black

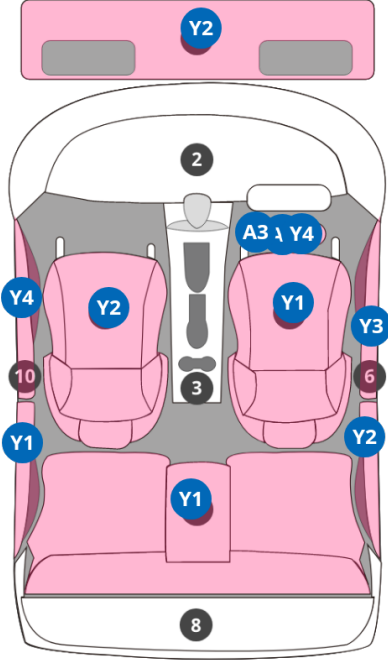
<b>Interior Evaluation :</b> <span style="float: right; color: red; font-weight: bold;">C</span>	<b>Exterior Evaluation :</b> <span style="float: right; color: red; font-weight: bold;">E</span>

<p><b>a</b> : Cut, Fray <b>d</b> : Loose, Deformed <b>k</b> : Animal Hair <b>s</b> : Smell <b>t</b> : Cigarette Burns <b>x</b> : Defective <b>y</b> : Stain</p>

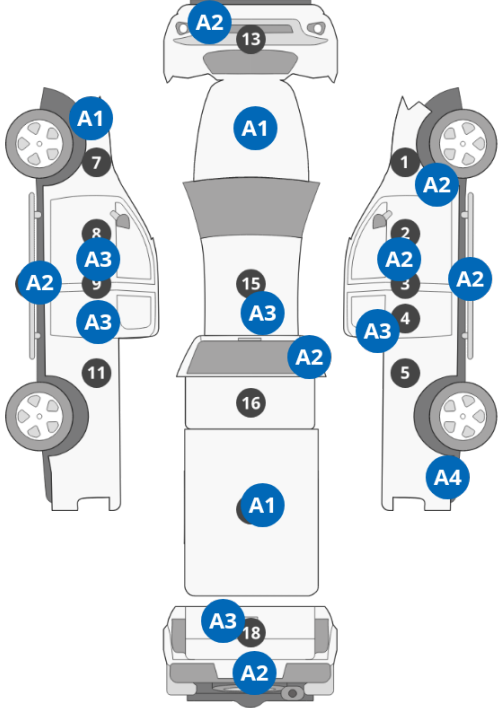
<p><b>A</b> : Scratch <b>AU</b> : Scratch &amp; Dent <b>B</b> : Modified <b>C</b> : Corrosion <b>G</b> : Stone chip <b>P</b> : Faded <b>S</b> : Rust <b>SC</b> : Rust &amp; Corrosion <b>U</b> : Dent <b>X</b> : Defective <b>Y</b> : Crack, Gap</p>
<p><b>Remarks</b> (R) Front Seat - Grime - Minimal / Carpet - Worn, Scratch, Cut, Crack - Small / (R) Front Floor Mat - Grime - Large / (R) Front Trim - Grime - Medium / (R) Rear Trim - Grime - Small / Rear Seat - Grime - Minimal / (L) Rear Trim - Grime - Minimal / (L) Front Trim - Grime - Large / (L) Front Floor Mat - Cut, Crack - Medium / (L) Front Seat - Grime - Small / Ceiling - Grime - Small</p>	<p><b>Remarks</b> (L) Rear Door, Molding - Scratch - Medium / Bonnet, Headlight - Scratch - Minimal / (R) Guard Frame - Scratch - Large / (R) Rear Door, Molding - Scratch - Medium / (R) Front Door, Molding - Scratch - Small / (R) Front Fender, Molding - Scratch - Small / Front Bumper, Grille, Lamps - Scratch - Small / (L) Front Fender, Molding - Scratch - Minimal / (L) Step, In-panel, Side Spoiler - Scratch - Small / (L) Front Door, Molding - Scratch - Medium / Rear Gate - Scratch - Medium / Rear Bumper, Lamps, Panels - Scratch - Small / Cargo Bed Floor - Scratch - Minimal / Roof - Scratch - Medium / Cab Back Panel - Scratch - Small / (R) Step, In-panel, Side Spoiler - Scratch - Small</p>
