General Information

Make	Toyota	Model	Corolla Altis
YOM	2023	Odo Meter Reading	43,542
Registration No.	NIF3610	Chassis No.	MR2BB3BE2N2003211
CC	1.6	Transmission	CVT
Fuel Type	Gas	Type of Body	Sedan
Colour	White

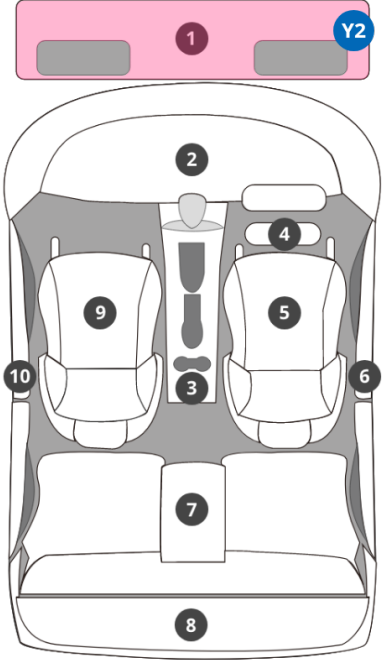
Interior Evaluation : A	Exterior Evaluation : D

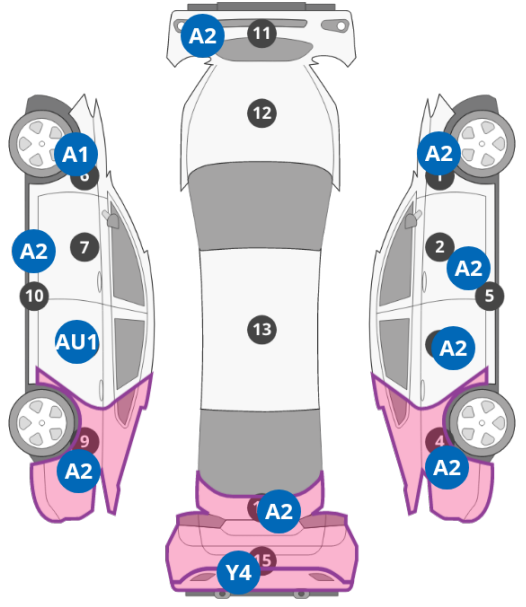
<p>A : Scratch AU : Scratch & Dent B : Modified C : Corrosion G : Stone chip P : Faded S : Rust SC : Rust & Corrosion U : Dent X : Defective Y : Crack, Gap</p>
Remarks Ceiling - Grime - Small	Remarks (R) Step - Repair Traces - Yes / (L) Step - Repair Traces - Yes / (L) Rear Fender - Repair Traces - Yes / (R) Rear Fender - Repair Traces - Yes / (L) Rear Fender, Molding - Repair mark - Yes / (R) Rear Fender, Molding - Repair mark - Yes / (L) Step, In-panel, Side Spoiler - Scratch - Small / (L) Rear Door, Molding - Scratch & Dent - Minimal / Rear Bumper, Lamps, Panels - Repair mark - Yes / Rear Bumper, Lamps, Panels - Crack, Gap - Large / Trunk Hood, Rear Gate - Repair mark - Yes / Front Bumper, Grille, Lamps - Scratch - Small / (R) Rear Door, Molding - Scratch - Small / (R) Front Door, Molding - Scratch - Small / (R) Front Fender, Molding - Scratch - Small / (L) Front Fender, Molding - Scratch - Minimal / (L) Rear Fender, Molding - Scratch - Small / (R) Rear Fender, Molding - Scratch - Small / Trunk Hood, Rear Gate - Scratch - Small
