## General Information

Date & Time: 03, Mar, 2026 15:46

<b>Make</b>	Toyota	<b>Model</b>	Avanza
<b>YOM</b>	2025	<b>Odo Meter Reading</b>	18,425
<b>Registration No.</b>	NJA4250	<b>Chassis No.</b>	MHFAA1BY6R0037372
<b>CC</b>	1.3	<b>Transmission</b>	CVT
<b>Fuel Type</b>	Gas	<b>Type of Body</b>	Wagon
<b>Colour</b>	Silver

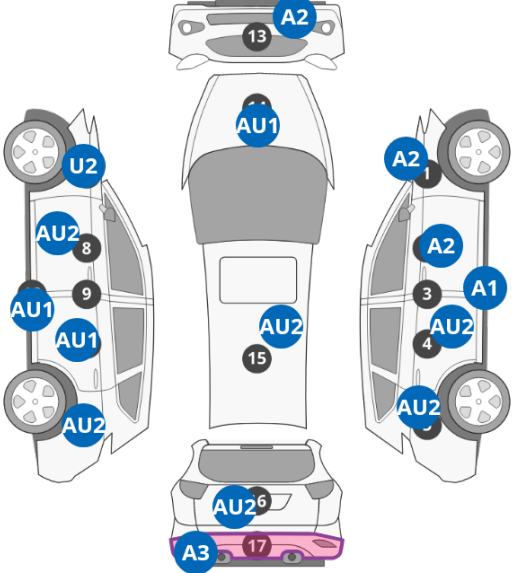
<p><b>A</b> : Scratch <b>AU</b> : Scratch &amp; Dent <b>B</b> : Modified <b>C</b> : Corrosion <b>G</b> : Stone chip <b>P</b> : Faded <b>S</b> : Rust <b>SC</b> : Rust &amp; Corrosion <b>U</b> : Dent <b>X</b> : Defective <b>Y</b> : Crack, Gap</p>
<p><b>Remarks</b> (R) Front Floor Mat - Grime - Small / Rear Seat - Grime - Minimal / (L) Front Seat - Grime - Small / (R) Front Seat - Grime - Small / Dashboard - Worn, Scratch, Cut, Crack - Small / Ceiling - Grime - Minimal</p>	<p><b>Remarks</b> (L) Rear Fender, Molding - Scratch &amp; Dent - Small / Trunk Hood, Rear Gate - Scratch &amp; Dent - Small / Rear Bumper, Lamps, Panels - Repair mark - Yes / Rear Bumper, Lamps, Panels - Scratch - Medium / (R) Rear Fender, Molding - Scratch &amp; Dent - Small / (R) Rear Door, Molding - Scratch &amp; Dent - Small / (R) Front Door, Molding - Scratch - Small / (R) Front Fender, Molding - Scratch - Small / Bonnet, Headlight - Scratch &amp; Dent - Minimal / Front Bumper, Grille, Lamps - Scratch - Small / (L) Front Fender, Molding - Dent - Small / (L) Front Door, Molding - Scratch &amp; Dent - Small / (L) Rear Door, Molding - Scratch &amp; Dent - Minimal / (L) Step, In-panel, Side Spoiler - Scratch &amp; Dent - Minimal / Roof - Scratch &amp; Dent - Small / (R) Step, In-panel, Side Spoiler - Scratch - Minimal</p>
