General Information

| Make | Toyota | Model | Vios |
| Registration No. | NJF7617 | Chassis No. | PA1B18F3XS4292150 |

Body / Panel Condition

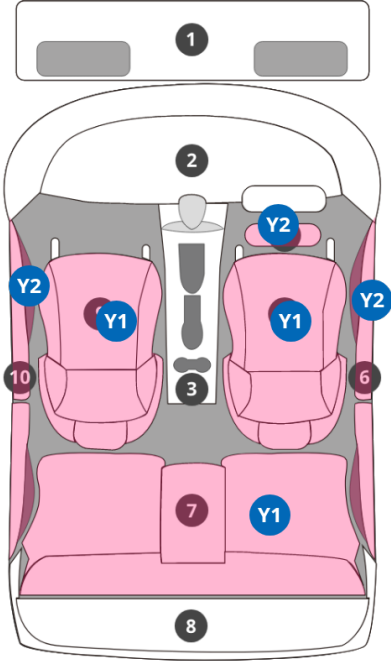
| <p>Remarks (L) Front Trim - Grime - Small / (R) Front Trim - Grime - Small / (L) Front Floor Mat - Grime - Small / (L) Front Seat - Grime - Minimal / (R) Front Seat - Grime - Minimal / Rear Seat - Grime - Minimal</p> | <p>Remarks Roof - Scratch - Small / (L) Front Door, Molding - Scratch & Dent - Small / (L) Rear Door, Molding - Scratch & Dent - Small / (L) Rear Fender, Molding - Scratch & Dent - Small / Trunk Hood, Rear Gate - Scratch - Small / (R) Rear Fender, Molding - Scratch - Medium / Rear Bumper, Lamps, Panels - Scratch - Small / (R) Front Door, Molding - Scratch - Medium / (R) Front Door, Molding - Repair mark - Yes / (R) Front Fender, Molding - Scratch - Small / Bonnet, Headlight - Scratch - Medium / (L) Step, In-panel, Side Spoiler - Scratch & Dent - Small / Front Bumper, Grille, Lamps - Scratch - Small / (R) Rear Door, Molding - Scratch & Dent - Small / (L) Front Fender, Molding - Scratch & Dent - Small</p> |
