General Information

Make	Suzuki	Model	Alto
YOM	2016	Odo Meter Reading	84,209
Registration No.	NDV4412	Chassis No.	MA3FB32S9G0783816
CC	0.8	Transmission	M/T
Fuel Type	Gas	Type of Body	Hatchback
Colour	Red

Body / Panel Condition

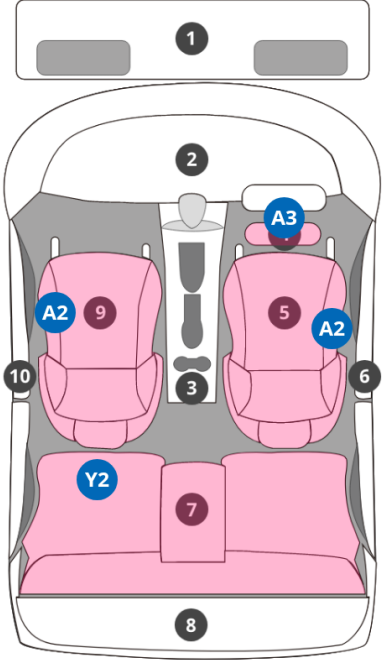
Interior Evaluation : B	Exterior Evaluation : E

<p>a : Cut, Fray d : Loose, Deformed k : Animal Hair s : Smell t : Cigarette Burns x : Defective y : Stain</p>

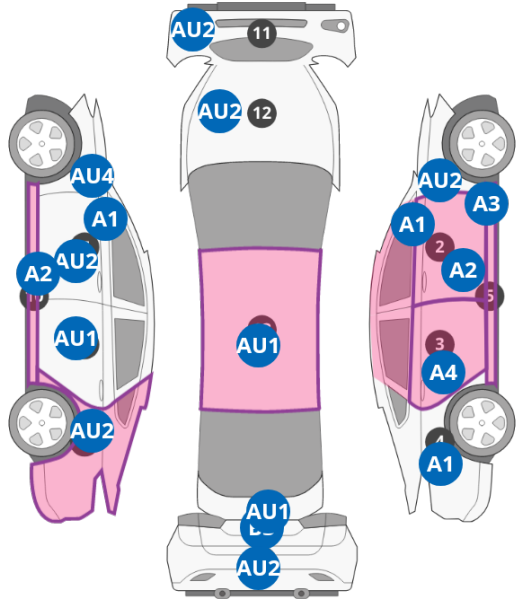
<p>A : Scratch AU : Scratch & Dent B : Modified C : Corrosion G : Stone chip P : Faded S : Rust SC : Rust & Corrosion U : Dent X : Defective Y : Crack, Gap</p>
<p>Remarks Rear Seat - Grime - Small / (L) Front Seat - Cut, Crack - Small / (R) Front Seat - Cut, Crack - Small / Carpet - Worn, Scratch, Cut, Crack - Medium</p>	<p>Remarks (R) Front Door - Repair Traces - Yes / (R) Step - Repair Traces - Yes / (R) Front Fender - Repair Traces - Yes / Bonnet - Repair Traces - Yes / (L) Front Fender - Repair Traces - Yes / (L) Front Door - Repair Traces - Yes / (L) Step - Repair Traces - Yes / (L) Rear Door - Repair Traces - Yes / (L) Rear Fender - Repair Traces - Yes / Trunk Hood, Rear Gate - Repair Traces - Yes / (R) Rear Fender - Repair Traces - Yes / (R) Rear Door - Repair Traces - Yes / Roof - Repair Traces - Yes / Overall Exterior - Full Re-Paint in same color - Yes / (R) Front Fender, Molding - Scratch & Dent - Small / (R) Mirror - Scratch - Minimal / (R) Front Door, Molding - Repair mark - Yes / (R) Rear Door, Molding - Repair mark - Yes / (R) Step, In-panel, Side Spoiler - Repair mark - Yes / (R) Front Door, Molding - Scratch - Small / (R) Step, In-panel, Side Spoiler - Scratch - Medium / (R) Rear Door, Molding - Scratch - Large / Trunk Hood, Rear Gate - Modified - Medium / (R) Rear Fender, Molding - Scratch - Minimal / Roof - Repair mark - Yes / Roof - Scratch & Dent - Minimal / (L) Rear Fender, Molding - Repair mark - Yes / Rear Bumper, Lamps, Panels - Scratch & Dent - Small / Trunk Hood, Rear Gate - Scratch & Dent - Minimal / (L) Rear Fender, Molding - Scratch & Dent - Small / (L) Rear Door, Molding - Scratch & Dent - Minimal / (L) Front Door, Molding - Scratch & Dent - Small / (L) Mirror - Scratch - Minimal / (L) Step, In-panel, Side Spoiler - Repair mark - Yes / (L) Step, In-panel, Side Spoiler - Scratch - Small / (L) Front Fender, Molding - Scratch & Dent - Large / Bonnet, Headlight - Scratch & Dent - Small / Front Bumper, Grille, Lamps - Scratch & Dent - Small</p>
