General Information

Date & Time: 03, Mar, 2026 16:26

Make	Toyota	Model	Fortuner
YOM	2022	Odo Meter Reading	120,738
Registration No.	FAJ5972	Chassis No.	MHFAA8GS6N0778446
CC	2.8	Transmission	A/T
Fuel Type	Diesel	Type of Body	SUV
Colour	Gray

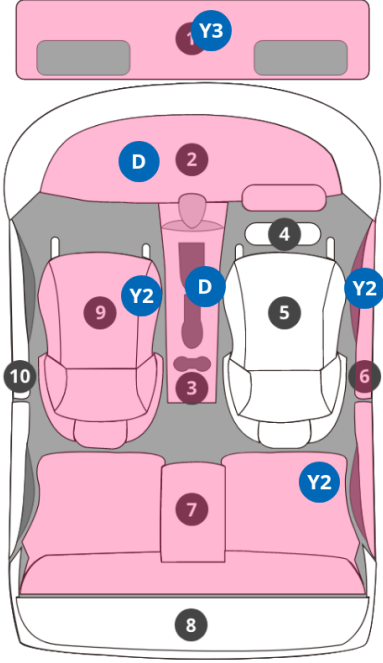
Interior Evaluation : B	Exterior Evaluation : C

<p>a : Cut, Fray d : Loose, Deformed k : Animal Hair s : Smell t : Cigarette Burns x : Defective y : Stain</p>

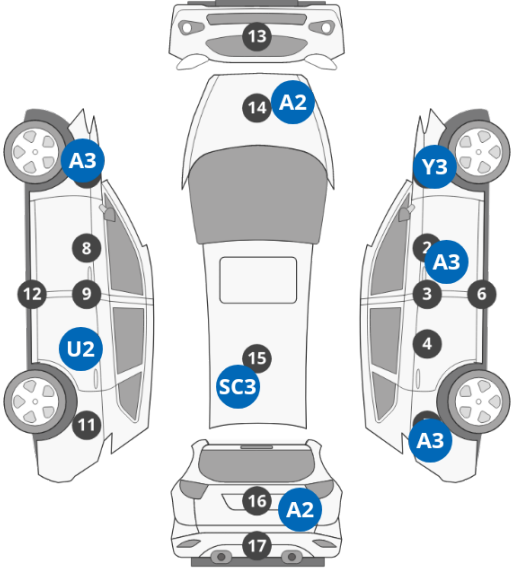
<p>A : Scratch AU : Scratch & Dent B : Modified C : Corrosion G : Stone chip P : Faded S : Rust SC : Rust & Corrosion U : Dent X : Defective Y : Crack, Gap</p>
<p>Remarks Ceiling - Grime - Medium / (R) Front Trim - Grime - Small / Dashboard - Traces of Adhesive Tape - Yes / Rear Seat - Grime - Small / Console, Switchs, Vents - Repair Mark - Yes / (L) Front Seat - Grime - Small</p>	<p>Remarks (R) Step - Repair Traces - Yes / Bonnet - Repair Traces - Yes / (L) Front Door - Repair Traces - Yes / (L) Step - Repair Traces - Yes / (L) Rear Door - Repair Traces - Yes / (L) Rear Fender - Repair Traces - Yes / Trunk Hood, Rear Gate - Repair Traces - Yes / (R) Rear Fender - Repair Traces - Yes / (R) Front Door, Molding - Scratch - Medium / (L) Front Fender, Molding - Scratch - Medium / Bonnet, Headlight - Scratch - Small / (L) Rear Door, Molding - Dent - Small / (R) Rear Fender, Molding - Scratch - Medium / Roof - Rust, Corrosion - Medium / Trunk Hood, Rear Gate - Scratch - Small / (R) Front Fender, Molding - Crack, Gap - Medium</p>
