General Information

Make	Toyota	Model	Avanza
YOM	2022	Odo Meter Reading	77,087
Registration No.	FAN6971	Chassis No.	MHFAA1BY4N0005885
CC	1.3	Transmission	CVT
Fuel Type	Gas	Type of Body	MPV
Colour	Green

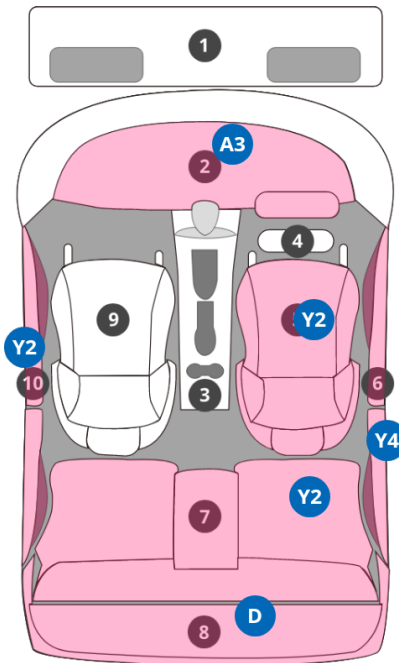
Interior Evaluation : C	Exterior Evaluation : D

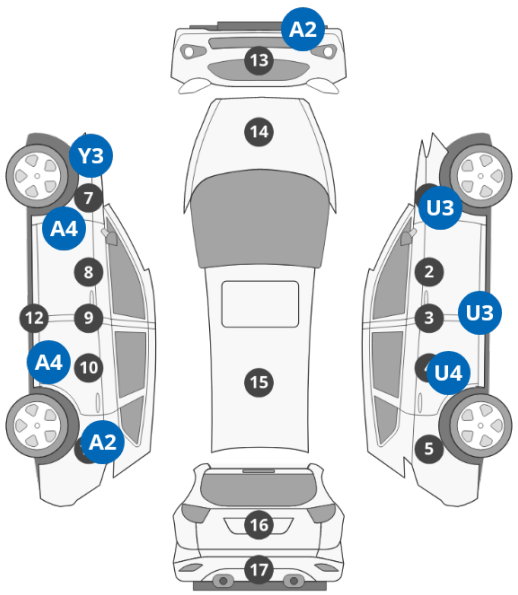
<p>A : Scratch AU : Scratch & Dent B : Modified C : Corrosion G : Stone chip P : Faded S : Rust SC : Rust & Corrosion U : Dent X : Defective Y : Crack, Gap</p>
<p>Remarks Trunk Room - Repair Mark - Yes / (R) Front Seat - Grime - Small / (R) Rear Trim - Grime - Large / Rear Seat - Grime - Small / (L) Front Trim - Grime - Small / Dashboard - Worn, Scratch, Cut, Crack - Medium</p>	<p>Remarks (R) Front Door - Repair Traces - Yes / (R) Step - Repair Traces - Yes / (R) Front Fender - Repair Traces - Yes / Bonnet - Repair Traces - Yes / (L) Front Fender - Repair Traces - Yes / (L) Front Door - Repair Traces - Yes / (L) Step - Repair Traces - Yes / (L) Rear Door - Repair Traces - Yes / (L) Rear Fender - Repair Traces - Yes / Trunk Hood, Rear Gate - Repair Traces - Yes / (R) Rear Fender - Repair Traces - Yes / (R) Rear Door - Repair Traces - Yes / Roof - Repair Traces - Yes / (R) Rear Door, Molding - Dent - Large / (L) Rear Fender, Molding - Scratch - Small / (L) Rear Door, Molding - Scratch - Large / (L) Front Door, Molding - Scratch - Large / (L) Front Fender, Molding - Crack, Gap - Medium / (R) Front Fender, Molding - Dent - Medium / (R) Front Door, Molding - Dent - Medium / Front Bumper, Grille, Lamps - Scratch - Small</p>
