General Information

Make	Hyundai	Model	Grand Starex
YOM	2015	Odo Meter Reading	181,595
Registration No.	ABE6627	Chassis No.	KMHWG81HAFU729683
CC	2.5	Transmission	M/T
Fuel Type	Diesel	Type of Body	Van
Colour	White

Body / Panel Condition

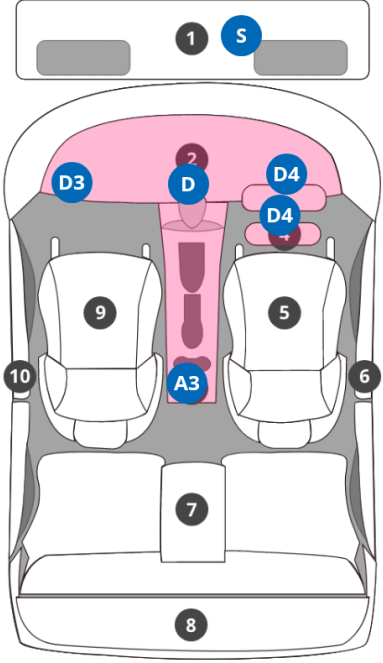
Interior Evaluation : C	Exterior Evaluation : E

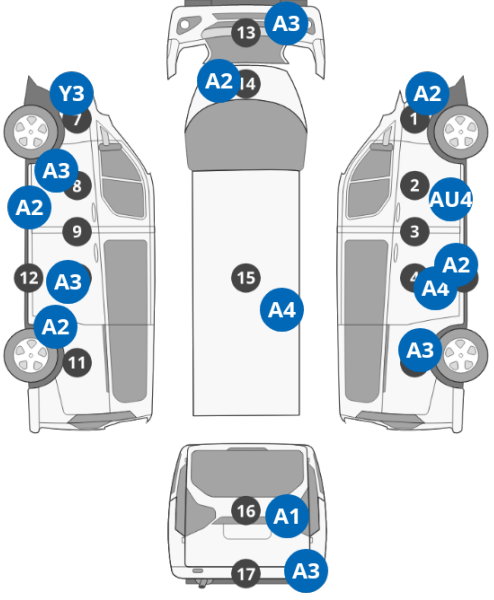
<p>A : Scratch AU : Scratch & Dent B : Modified C : Corrosion G : Stone chip P : Faded S : Rust SC : Rust & Corrosion U : Dent X : Defective Y : Crack, Gap</p>
<p>Remarks Overall Interior - Worn as per age - Yes / Dashboard - Loose, Deformed - Medium / (L) Front Floor Mat - Worked - Large / Glove Box - Loose, Deformed - Large / Overall Interior - Smell - Yes / Dashboard - Traces of Adhesive Tape - Yes / Console, Switches, Vents - Worn, Scratch, Cut, Crack - Medium</p>	<p>Remarks (L) Rear Door - Repair Traces - Yes / (R) Rear Door - Repair Traces - Yes / (R) Rear Fender, Molding - Scratch - Medium / (R) Rear Door, Molding - Scratch - Large / (R) Front Door, Molding - Scratch & Dent - Large / (R) Front Fender, Molding - Scratch - Small / Front Bumper, Grille, Lamps - Scratch - Medium / Bonnet, Headlight - Scratch - Small / (L) Front Fender, Molding - Crack, Gap - Medium / (L) Front Door, Molding - Scratch - Medium / (L) Rear Door, Molding - Scratch - Medium / (L) Step, In-panel, Side Spoiler - Scratch - Small / (L) Rear Fender, Molding - Scratch - Small / Trunk Hood, Rear Gate - Scratch - Minimal / Rear Bumper, Lamps, Panels - Scratch - Medium / (R) Step, In-panel, Side Spoiler - Scratch - Small / Roof - Scratch - Large</p>
