## General Information

| Make | MG | Model | MG 5 |
| Registration No. | GBI3105 | Chassis No. | LSJA36E38SZ609951 |

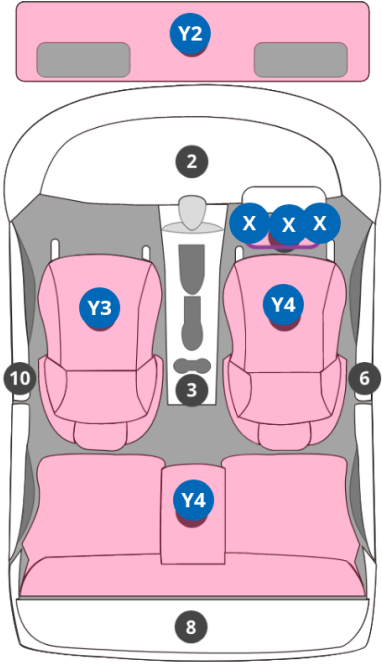
| Interior Evaluation : <span style="color: red;">C</span> | Exterior Evaluation : <span style="color: red;">E</span> |
| <b>Remarks</b><br>(R) Front Floor Mat - Missing - Yes / Mat Other - Missing - Yes / (L) Front Floor Mat - Missing - Yes / (R) Front Seat - Grime - Large / Ceiling - Grime - Small / Rear Seat - Grime - Large / (L) Front Seat - Grime - Medium | <b>Remarks</b><br>(R) Rear Door - Repair Traces - Yes / (L) Front Fender, Molding - Scratch - Medium / (L) Mirror - Scratch - Small / (L) Front Door, Molding - Scratch - Small / (L) Rear Door, Molding - Scratch - Medium / (L) Rear Fender, Molding - Scratch - Small / Trunk Hood, Rear Gate - Scratch - Medium / (R) Rear Fender, Molding - Scratch - Small / Rear Bumper, Lamps, Panels - Scratch - Small / (R) Rear Door, Molding - Scratch - Medium / (R) Front Door, Molding - Scratch - Medium / (R) Step, In-panel, Side Spoiler - Scratch & Dent - Minimal / (R) Mirror - Scratch - Small / (R) Front Fender, Molding - Scratch - Small / Bonnet, Headlight - Scratch - Small / Front Bumper, Grille, Lamps - Scratch & Dent - Medium / Roof - Scratch - Small |
