## General Information

| Make | Toyota | Model | Vios |

## Body / Panel Condition

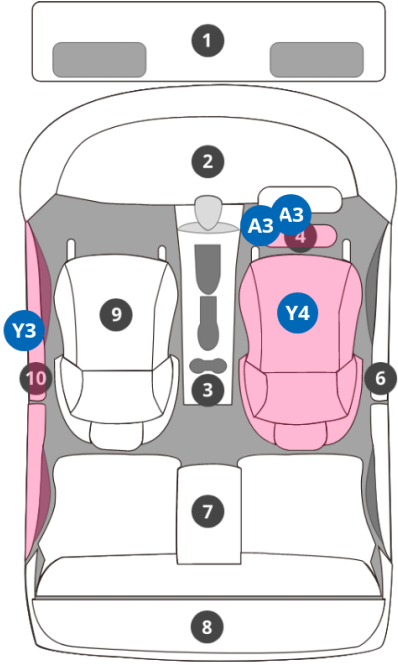
| Interior Evaluation : <span style="color: red;">C</span> | Exterior Evaluation : <span style="color: red;">E</span> |
|---|---|
| <b>Remarks</b><br>(R) Front Seat - Grime - Large / (L) Front Trim - Grime - Medium / (L) Front Floor Mat - Cut, Crack - Medium / Carpet - Worn, Scratch, Cut, Crack - Medium | <b>Remarks</b><br>(R) Front Door - Repair Traces - Yes / (R) Front Fender - Repair Traces - Yes / Bonnet - Repair Traces - Yes / (L) Front Fender - Repair Traces - Yes / (L) Front Door - Repair Traces - Yes / (L) Rear Door - Repair Traces - Yes / (L) Rear Fender - Repair Traces - Yes / Trunk Hood, Rear Gate - Repair Traces - Yes / (R) Rear Fender - Repair Traces - Yes / (R) Rear Door - Repair Traces - Yes / Roof - Repair Traces - Yes / (R) Rear Door, Molding - Scratch - Large / (R) Front Door, Molding - Scratch - Medium / Front Bumper, Grille, Lamps - Scratch - Large / Bonnet, Headlight - Dent - Medium / (L) Front Door, Molding - Scratch & Dent - Large / (L) Step, In-panel, Side Spoiler - Dent - Medium / (L) Rear Door, Molding - Dent - Small / (L) Rear Fender, Molding - Scratch & Dent - Small / Rear Bumper, Lamps, Panels - Scratch - Large / Roof - Scratch & Dent - Medium |
