## General Information

| Make | MG | Model | ZS |
| Registration No. | MBD6127 | Chassis No. | LSJW74U38RZ099062 |

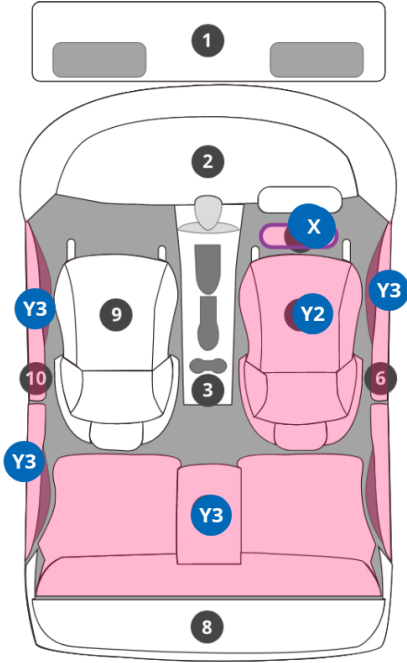
| Interior Evaluation : <b>B</b> | Exterior Evaluation : <b>C</b> |
|---|---|
| <b>Remarks</b><br>(R) Front Floor Mat - Missing - Yes / (L) Front Floor Mat - Missing - Yes / Mat Other - Missing - Yes / (R) Front Seat - Grime - Small / (R) Front Trim - Grime - Medium / Rear Seat - Grime - Medium / (L) Rear Trim - Grime - Medium / (L) Front Trim - Grime - Medium | <b>Remarks</b><br>(R) Front Door - Repair Traces - Yes / (R) Front Fender - Repair Traces - Yes / Bonnet - Repair Traces - Yes / (L) Front Fender - Repair Traces - Yes / (L) Front Door - Repair Traces - Yes / (L) Rear Door - Repair Traces - Yes / (L) Rear Fender - Repair Traces - Yes / Trunk Hood, Rear Gate - Repair Traces - Yes / (R) Rear Fender - Repair Traces - Yes / (R) Rear Door - Repair Traces - Yes / Roof - Repair Traces - Yes / (L) Rear Door, Molding - Scratch - Medium / Bonnet, Headlight - Scratch & Dent - Small / Front Bumper, Grille, Lamps - Scratch - Large / (R) Front Fender, Molding - Scratch - Small / (R) Front Door, Molding - Scratch & Dent - Small / (R) Rear Door, Molding - Scratch & Dent - Small / Rear Bumper, Lamps, Panels - Scratch - Small / (L) Front Door, Molding - Partially Missing - Yes / Roof - Scratch & Dent - Small |
