## General Information

| Make | Hyundai | Model | H100 |
| Registration No. | NJC5912 | Chassis No. | KMFZBX7KASU182881 |

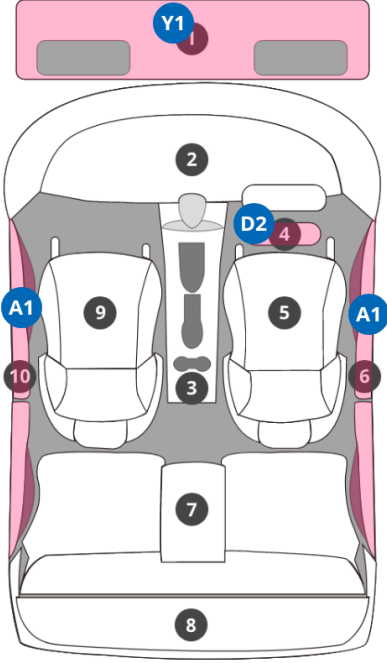
| Interior Evaluation : <b>A</b> | Exterior Evaluation : <b>E</b> |
| <b>Remarks</b><br>(R) Front Trim - Cut, Crack - Minimal / (L) Front Floor Mat - Worked - Small / (L) Front Trim - Cut, Crack - Minimal / Ceiling - Grime - Minimal | <b>Remarks</b><br>Front Bumper, Grille, Lamps - Scratch & Dent - Large / (L) Side Gate - Scratch & Dent - Large / Rear Bumper, Lamps, Panels - Scratch - Large / Cargo Bed Floor - Scratch & Dent - Large / Rear Gate - Scratch - Small / (R) Side Gate - Scratch & Dent - Medium / (R) Front Fender, Molding - Scratch & Dent - Medium / Roof - Scratch & Dent - Large / (R) Front Door, Molding - Scratch - Small / (L) Front Door, Molding - Scratch - Small / (L) Front Fender, Molding - Scratch - Small / Front Panel - Scratch - Minimal |
