## General Information

| Make | Hyundai | Model | H100 |
| Registration No. | NJA9943 | Chassis No. | KMFZBX7KASU179883 |

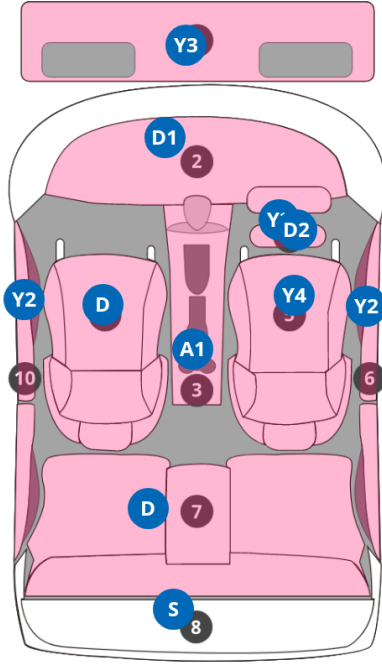
| Interior Evaluation : <span style="color: red;">C</span> | Exterior Evaluation : <span style="color: red;">C</span> |
| <p><b>Remarks</b></p> <p>(R) Front Seat - Grime - Large / (L) Front Floor Mat - Grime - Small / (R) Front Floor Mat - Worked - Small / Dashboard - Worked - Minimal / Overall Interior - Smell - Yes / Rear Seat - Worn - Yes / (L) Front Seat - Worn - Yes / (L) Front Trim - Grime - Small / (R) Front Trim - Grime - Small / Ceiling - Grime - Medium / Console, Switches, Vents - Worn, Scratch, Cut, Crack - Minimal</p> | <p><b>Remarks</b></p> <p>(R) Rear Corner Panel - Repair Traces - Yes / Front Panel - Scratch &amp; Dent - Small / Front Bumper, Grille, Lamps - Scratch - Small / (R) Front Fender, Molding - Scratch &amp; Dent - Minimal / (R) Front Door, Molding - Repair mark - Yes / (R) Front Door, Molding - Scratch &amp; Dent - Minimal / (R) Step, In-panel, Side Spoiler - Scratch &amp; Dent - Small / (R) Side Gate - Scratch &amp; Dent - Small / Rear Gate - Modified - Medium / Rear Gate - Scratch &amp; Dent - Small / Rear Bumper, Lamps, Panels - Scratch &amp; Dent - Small / (L) Side Gate - Scratch &amp; Dent - Small / (L) Step, In-panel, Side Spoiler - Scratch &amp; Dent - Small / (L) Front Door, Molding - Scratch &amp; Dent - Minimal / (L) Front Fender, Molding - Scratch &amp; Dent - Minimal / Roof - Scratch &amp; Dent - Small</p> |
