## General Information

| Make | Ford | Model | Explorer |
| YOM | 2013 | Odo Meter Reading | 98,014 |
| Registration No. | WOU425 | Chassis No. | 1FM5K7F93DGC84392 |

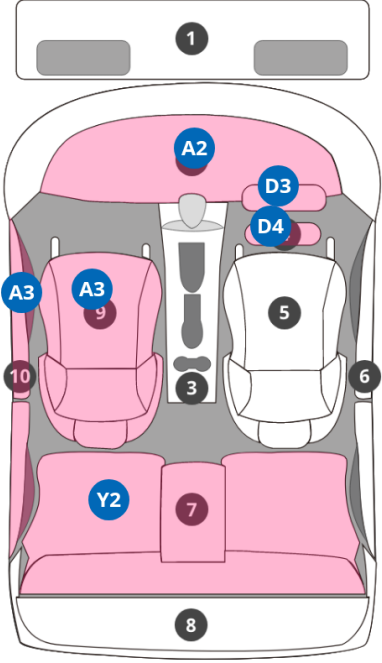
| Interior Evaluation : <b>C</b> | Exterior Evaluation : <b>E</b> |
|---|---|
| <p><b>Remarks</b></p> <p>Dashboard - Loose, Deformed - Medium / (L) Front Trim - Cut, Crack - Medium / Steering Wheel - Worn, Peel, Crack - Small / (L) Front Seat - Cut, Crack - Medium / Rear Seat - Grime - Small / Carpet - Worked - Large</p> | <p><b>Remarks</b></p> <p>(R) Front Door - Repair Traces - Yes / (R) Front Fender - Repair Traces - Yes / (L) Front Fender - Repair Traces - Yes / (L) Front Door - Repair Traces - Yes / (L) Rear Door - Repair Traces - Yes / (R) Rear Fender - Repair Traces - Yes / (R) Front Fender, Molding - Scratch - Small / (R) Mirror - Scratch - Small / (R) Front Door, Molding - Scratch &amp; Dent - Medium / (R) Rear Door, Molding - Repair mark - Difference in Color / (R) Rear Door, Molding - Scratch - Large / (R) Rear Fender, Molding - Scratch &amp; Dent - Large / Trunk Hood, Rear Gate - Scratch &amp; Dent - Small / Rear Bumper, Lamps, Panels - Scratch &amp; Dent - Small / Antennae - Damaged - Yes / Roof - Repair mark - Yes / (L) Rear Fender, Molding - Scratch - Medium / Roof - Scratch &amp; Dent - Large / (L) Side Window - Damaged - Large / (L) Front Door, Molding - Scratch - Large / (L) Mirror - Scratch - Minimal / (L) Rear Door, Molding - Scratch - Medium / (L) Front Fender, Molding - Scratch - Small / Bonnet, Headlight - Scratch &amp; Dent - Minimal / Front Bumper, Grille, Lamps - Scratch - Large / Front Windshield - Scratch, Stone chip - Medium</p> |
