## General Information

| Make | Mitsubishi | Model | Mirage |
| YOM | 2023 | Odo Meter Reading | 24,716 |
| Registration No. | NFP3424 | Chassis No. | PAEA13TJPNA000369 |

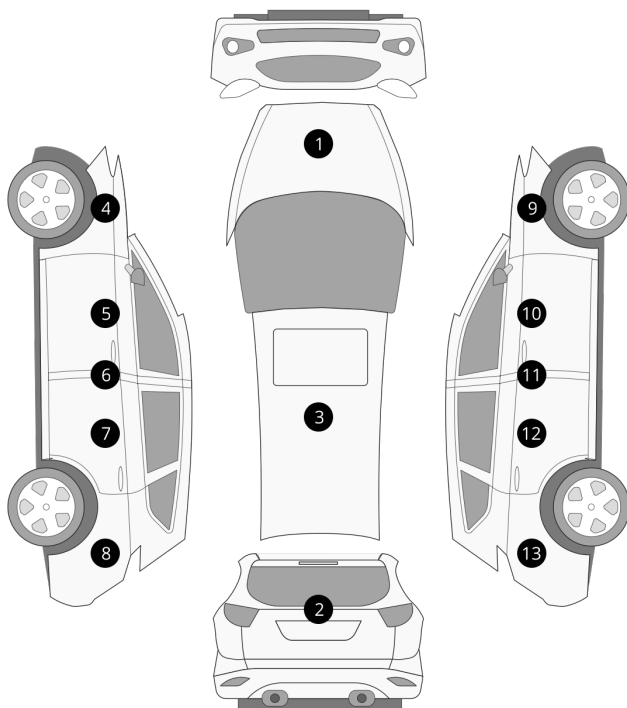
## Body / Panel Condition

| # | Area | Thickness(um) | | | |
|---|---|---|---|---|---|
| 8 | Left Back Panel | 244.3 | 354 | 203 | 176 |
| 9 | Right Front Fender | 850.6 | 991 | 1,118 | 443 |
| 10 | Right Front Door | 212.6 | 212 | 198 | 228 |
